COMPLIANCE REPORT
MUDDY HOLLOW CULVERT REMOVAL
FILE NUMBER 25358N

Submitted by the National Park Service
Point Reyes National Seashore
Point Reyes Station, California, 94956

COMPLIANCE REPORT – MUDDY HOLLOW CULVERT REMOVAL – FILE # 25358N

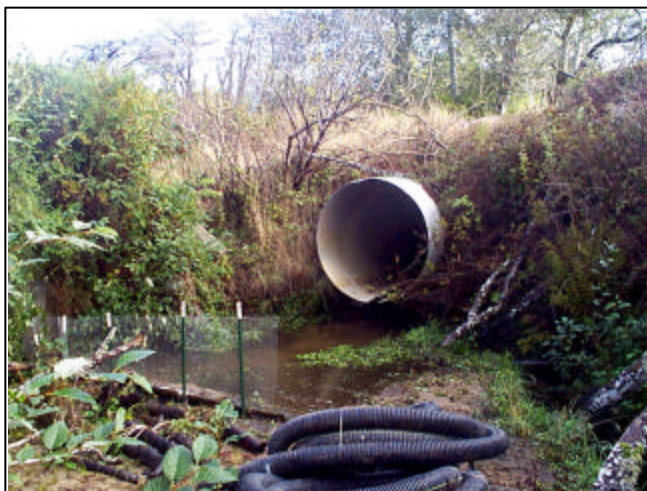
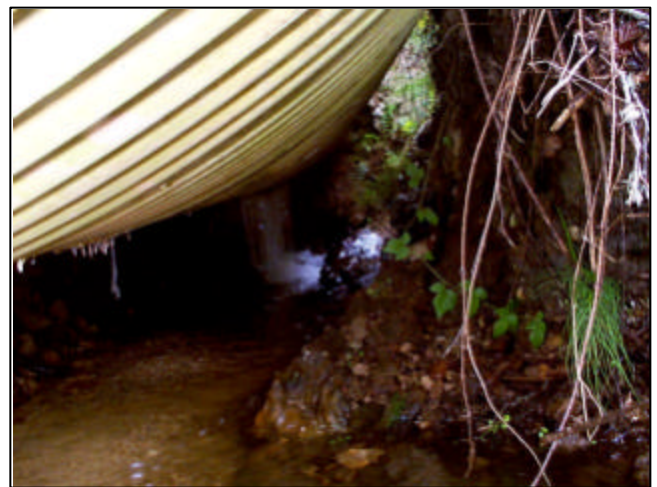
DETERIORATING CULVERT

Failed Culvert and Fish Impediment
