**INTERIM REPORT TO THE
CALIFORNIA STATE BOARD OF FORESTRY
AND FIRE PROTECTION**

**HILLSLOPE MONITORING
PROGRAM:**

*MONITORING RESULTS
FROM
1996 THROUGH 1998*

**JUNE 1999
SACRAMENTO, CALIFORNIA**

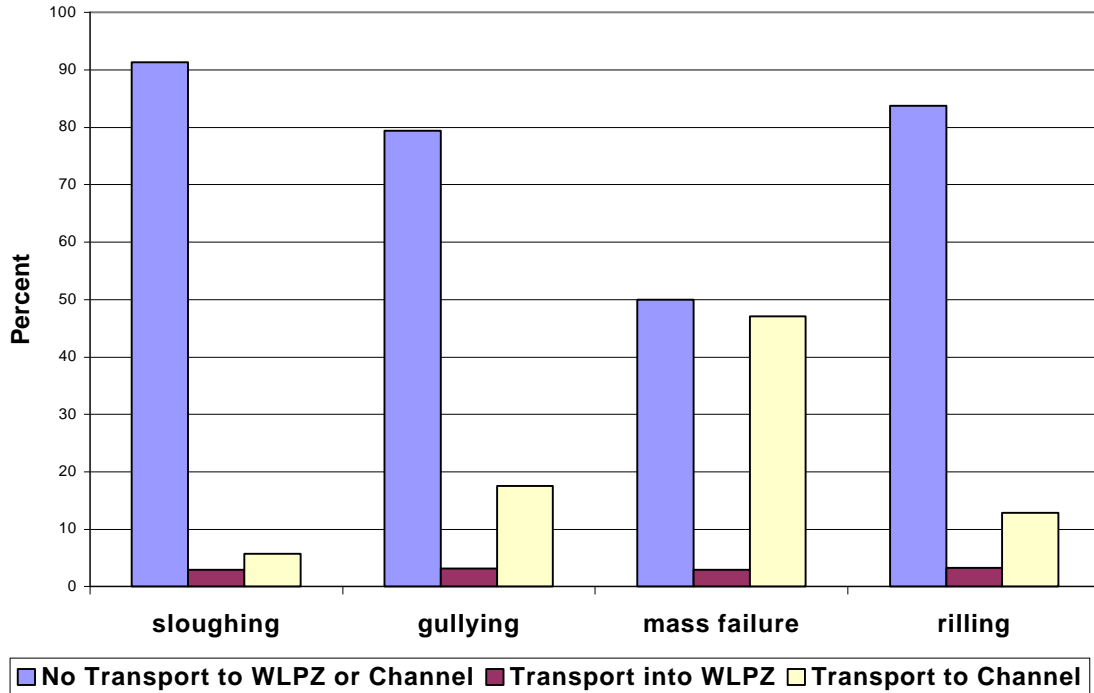
The location of sediment deposition resulting from these various types of erosion features is of critical concern when addressing protection of beneficial uses of water. Figure 3 displays the sediment deposition categories for the various types of erosion features previously described above. Only 6% of the sloughing features were found to have transported sediment to the channel; another 3% had material transported into the WLPZ. For gullying, about 18% of features had sediment transported into the channel, with another 3% deposited in the WLPZ. Mass wasting resulted in sediment transported into the channel 47% of the time, and material entering the WLPZ an additional 3% of the time. Finally, rilling features had sediment deposited in channels 13% of the time, with an additional 3% deposited in the WLPZ.

Figure 4. Sediment deposition sites for erosion features produced from current THPs and associated with road transects (percent of the number of occurrences for each feature type).

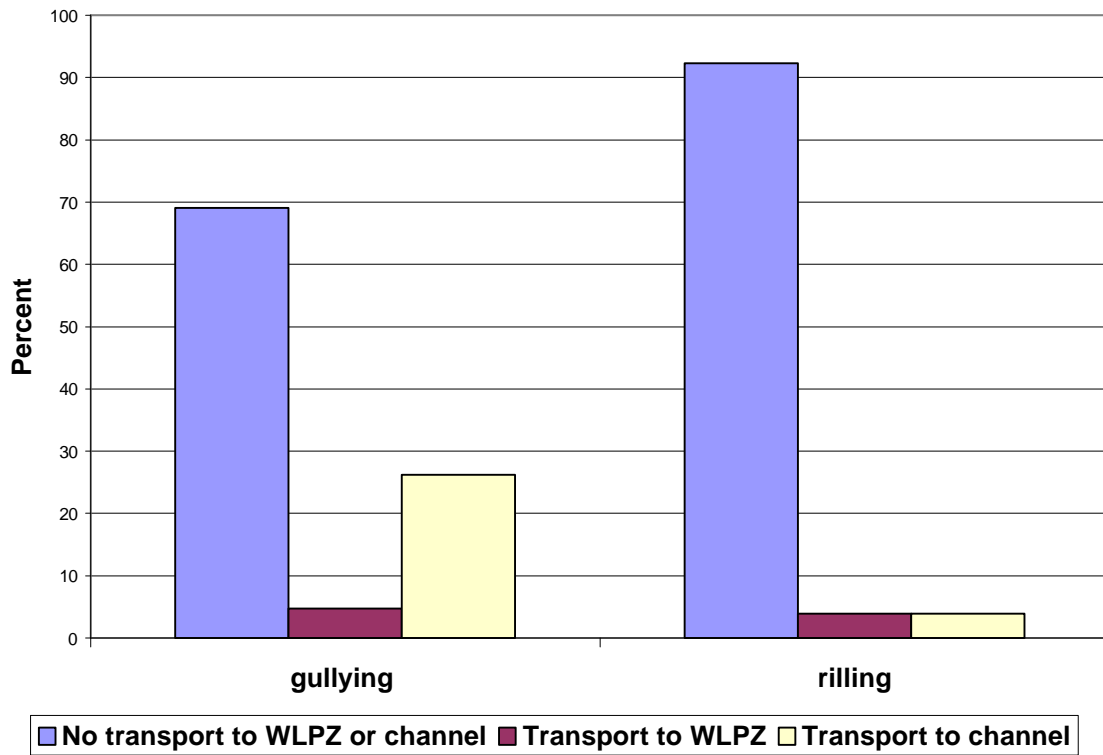
Figure 4 shows the frequency of sediment deposition sites for rilling and gullying. Sloughing and mass failures are not included because of the small number of occurrences. Approximately 4% of the rills deposited sediment into watercourses; another 4% deposited material into the WLPZ.¹¹ For gullying, 26% deposited material into channels, with another 5% depositing material into the WLPZ.

Figure 5. Sediment deposition sites for rilling and gullying produced from current THPs and associated with skid trail transects.

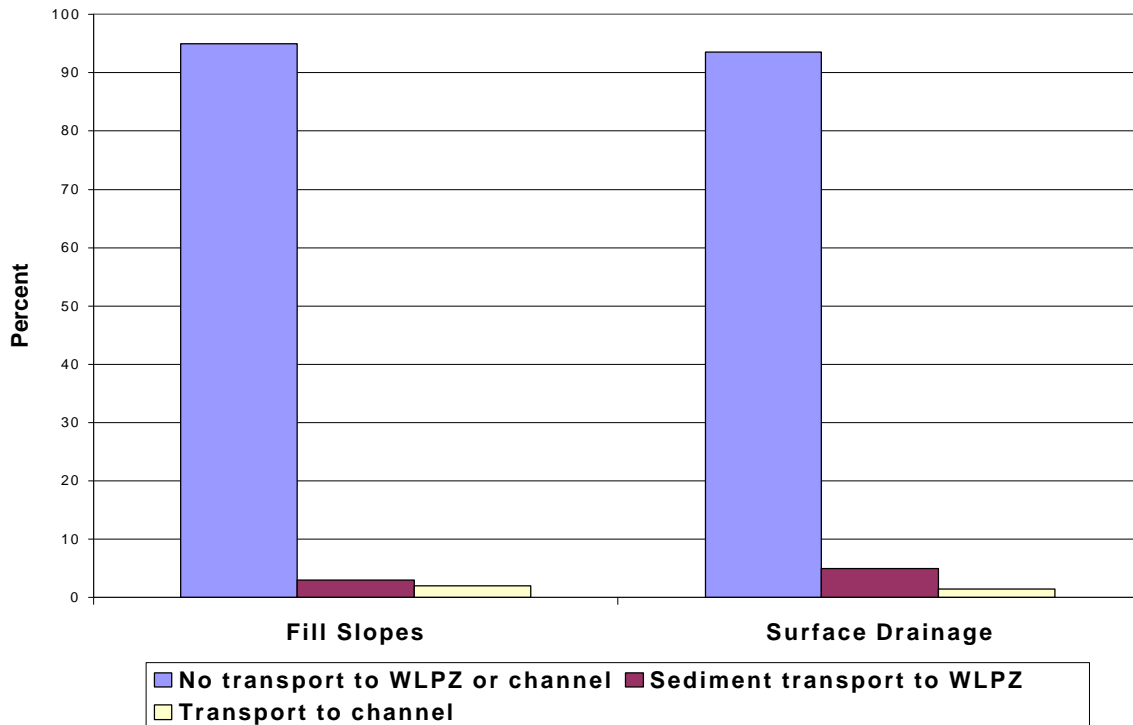
The location of sediment deposition originating from landing surfaces and fill slopes was also evaluated (Figure 5). For fill slopes, 2% of the time material entered channels, with another 3% reaching the WLPZ. Similarly for surface drainage, 1.5% reached channels, with another 5% reaching the WLPZ.

Figure 6. Sediment deposition sites associated with landing fill slopes and surface drainage.

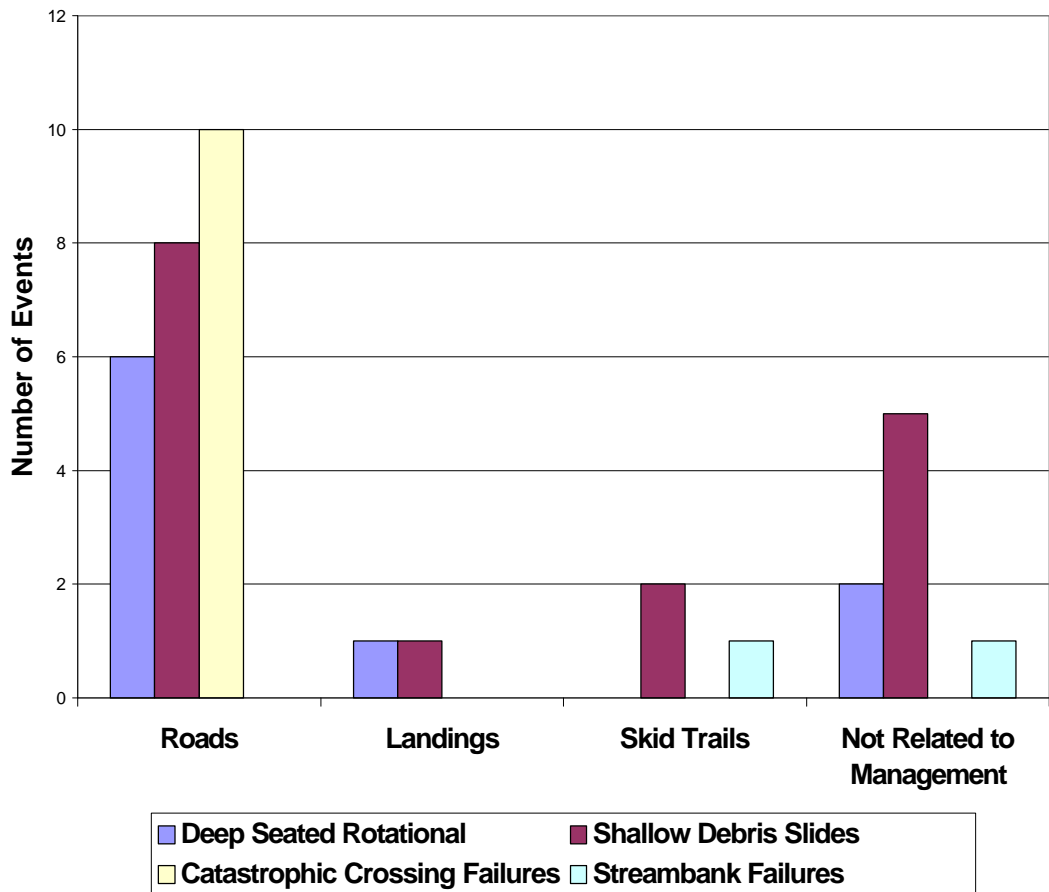
Figure 7. Causes of large erosion events and type of feature.
