Assessment of Moat Creek Fisheries and Prospects for Restoration

Prepared for: **Moat Creek Management Agency**
P.O. Box 423
Pt. Arena, California 95468

By: **Patrick Higgins**
Consulting Fisheries Biologist
791 Eighth Street, Suite N
Arcata, California 95521

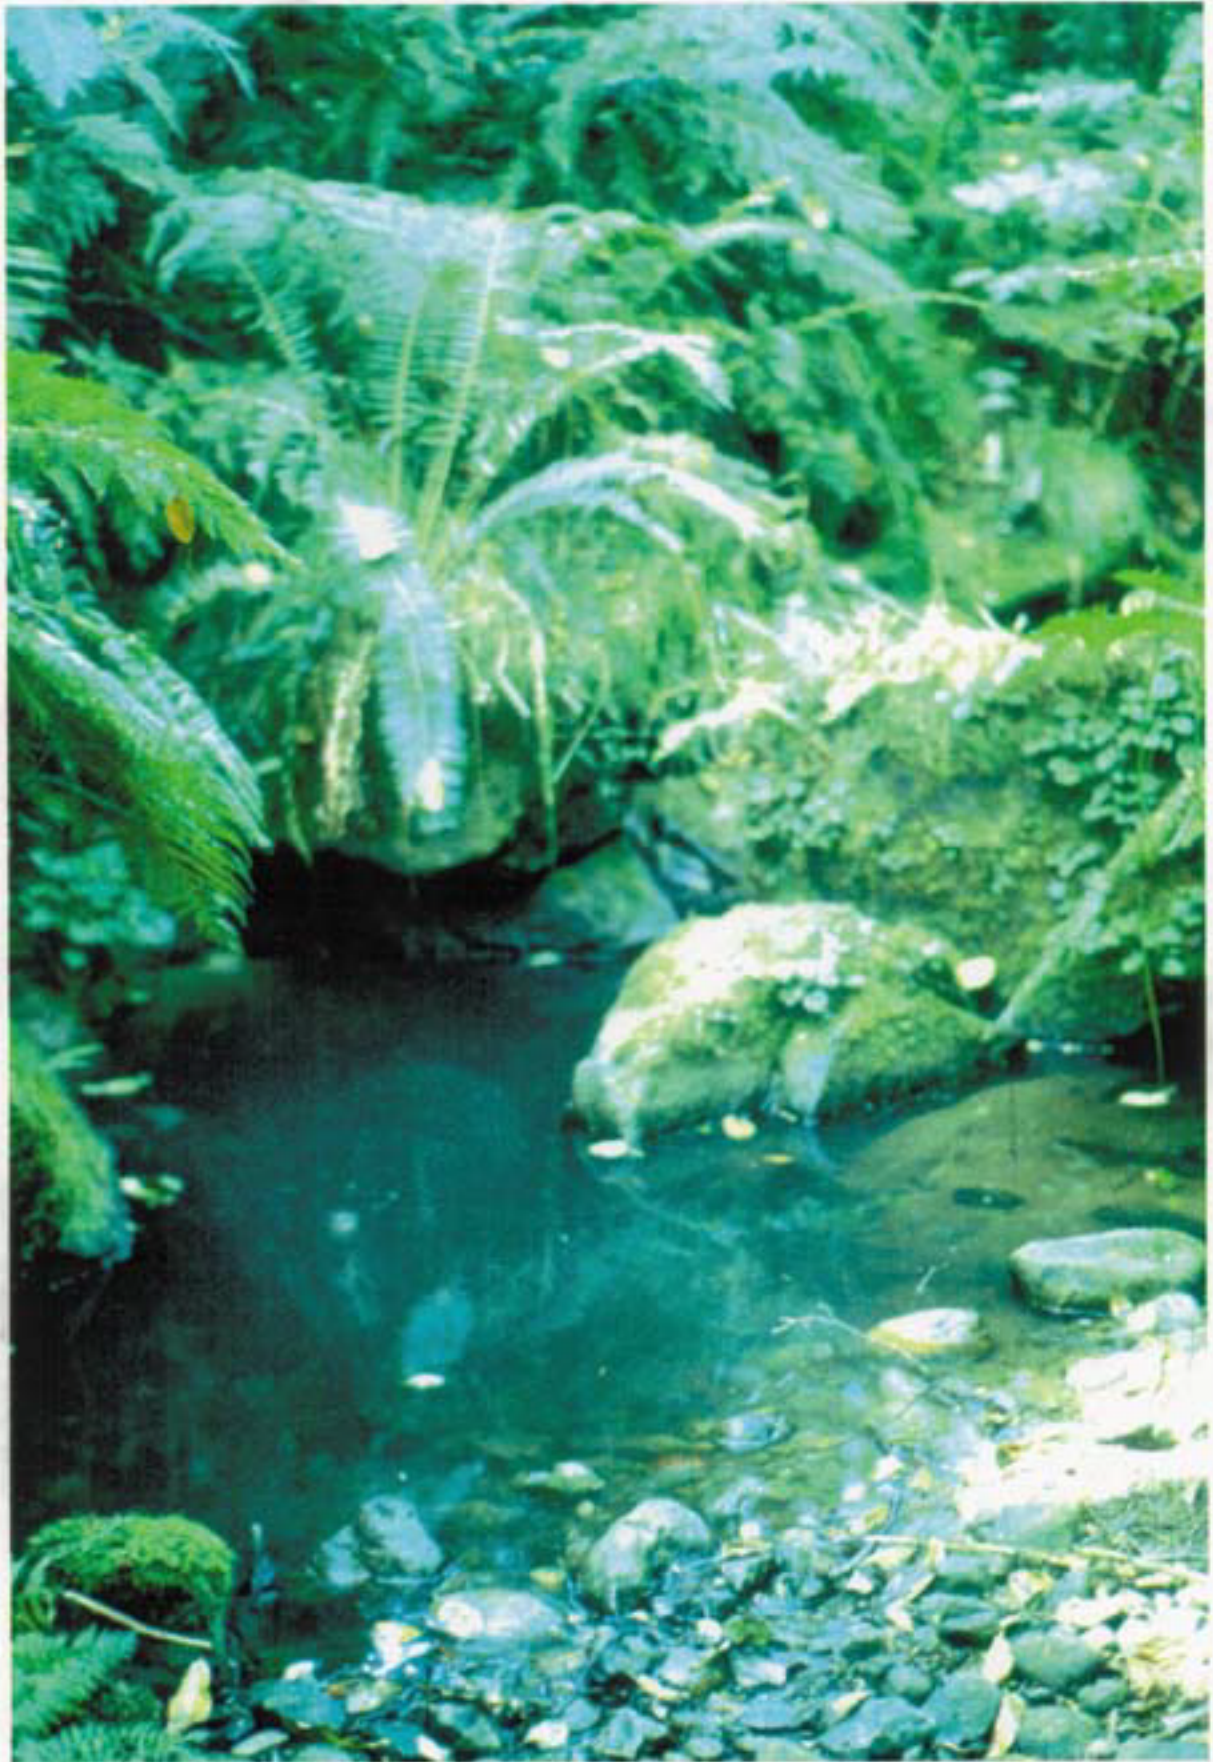
In the upper reach surveyed, above and below the 1992 spill site, the water temperature was 57° F. Moat Creek is incised in a narrow gorge in this reach and has approximately a 4% gradient. The stream bed is made up of predominantly coarse bed materials, including cobble and gravel (Photo #2). Very high densities of Pacific giant salamanders (*Dicamptodon ensatus*) were found during the survey. Three age classes seemed to be represented, with numerous two-inch long specimens, some four-inch long larvae and a few adults (8") that had retained gills and remained aquatic (Photo #3). Adult Pacific giant salamanders are usually terrestrial. Almost no trace of the spill was evident anywhere in the stream channel. No juvenile steelhead or rainbow trout were found in this upper reach despite a reported sighting just after the spill (Higgins, 1992). Discussions with Rick Macedo and Ed Ramos led to the conclusion that temporary CDFG personnel had made the report and had most likely mistaken a large Pacific giant salamander for a resident trout. A more extensive electrofishing survey of this stream reach in 1992 by Weldon Jones, a California Department of Fish and Game Biologist, also found no salmonids.

The bed of Moat Creek in the upper reach is composed of bedrock, boulders, cobble and gravel, all of a uniform orange sandstone. The stream side rocks were covered with mosses to a level about four inches above summer base flow levels (Photo #2). The lack of scour on stream side rocks indicated that fluctuations in flow are moderate even during winter storms. It is likely that the healthy watershed conditions that prevail in upper Moat Creek moderate rapid peaks in stream flow even during intense rainfall. While it appears that substrate composition here might allow for salmonid production, the small size of the stream in this headwater area might preclude successful steelhead spawning. Native rainbow trout also occur frequently in coastal streams but are absent from in Moat Creek. One explanation for their absence could be that they may have been out-competed by Pacific giant salamanders.

Photo #2. The upper reach of Moat Creek has coarse bed materials and cool water but may be too small to accommodate steelhead spawning. Moss on stream side rocks indicates that the stream only fluctuates mildly during winter.

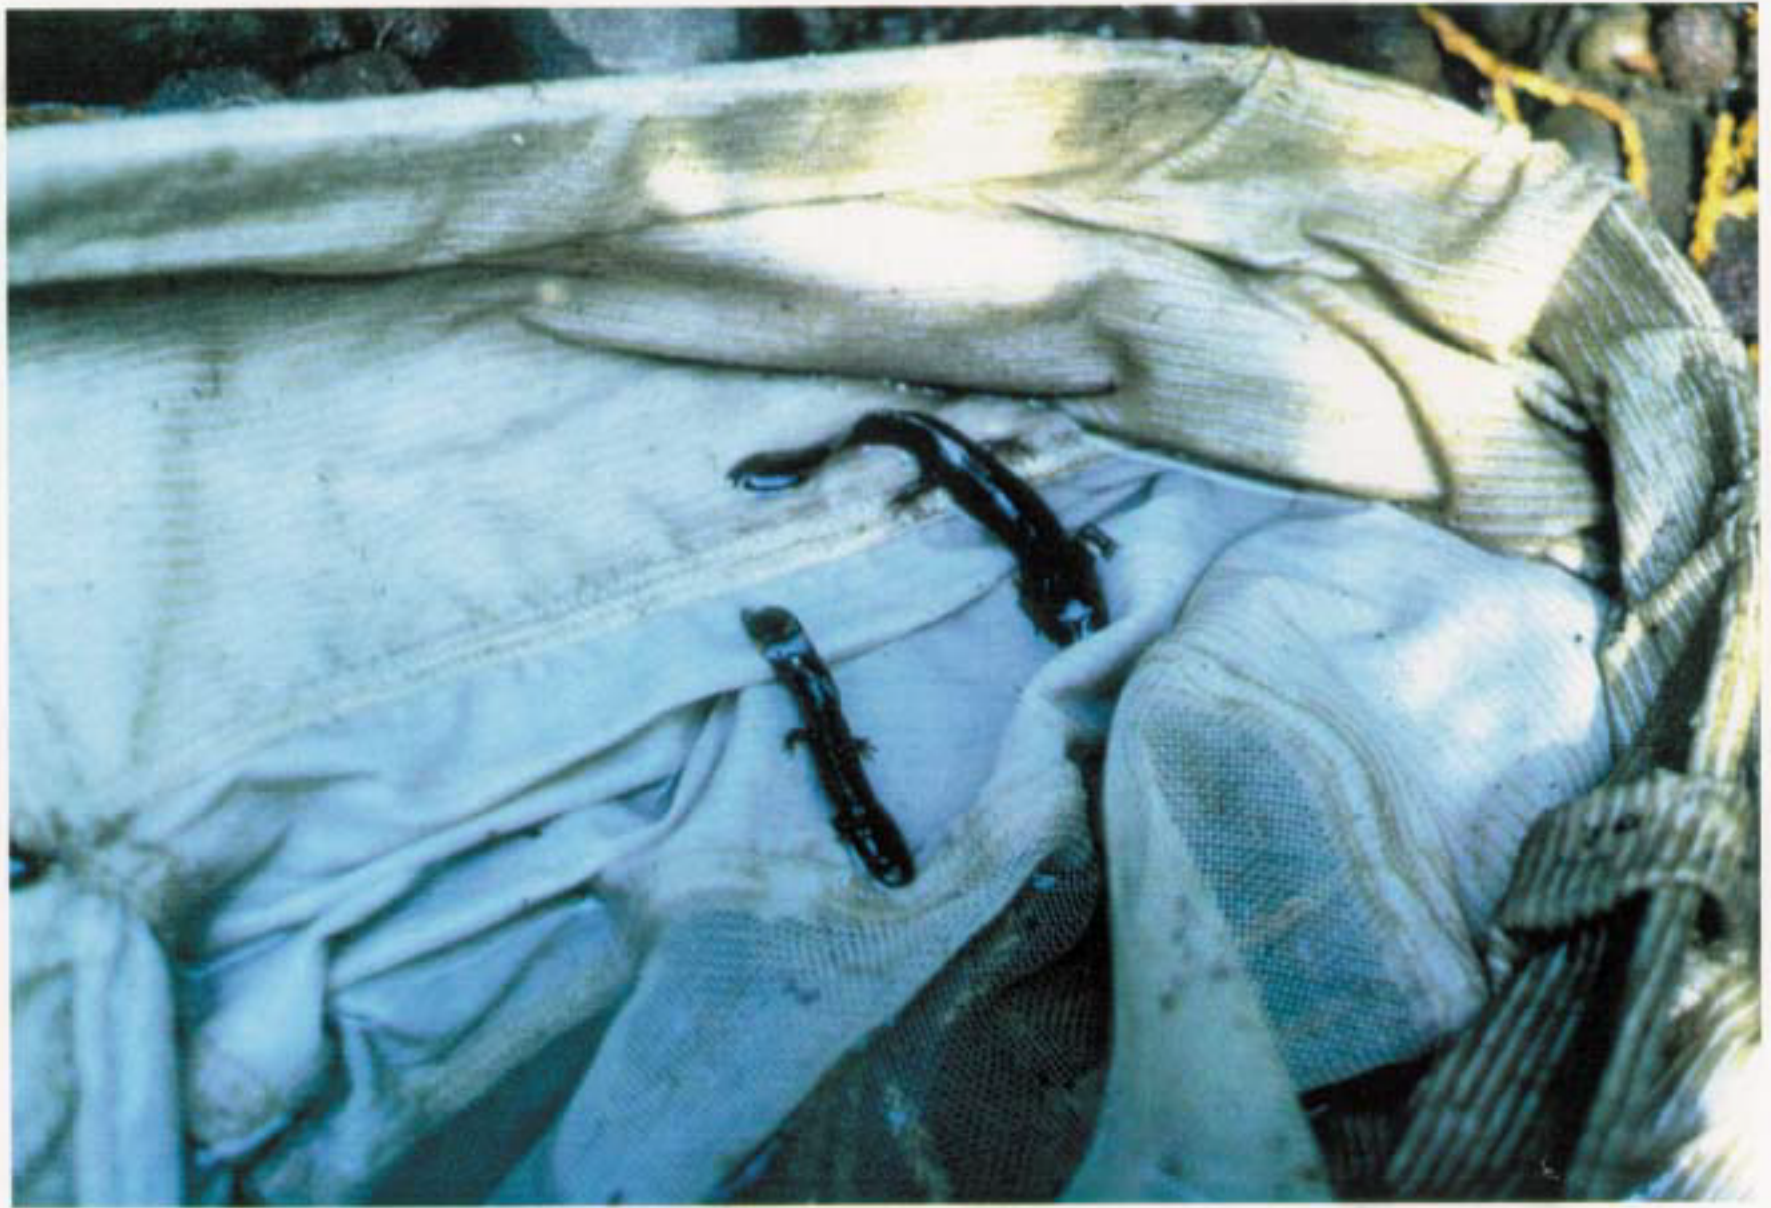
Photo #3. Pacific giant salamanders are abundant in upper Moat Creek. The two different sizes of larval salamanders shown probably represent different age classes.

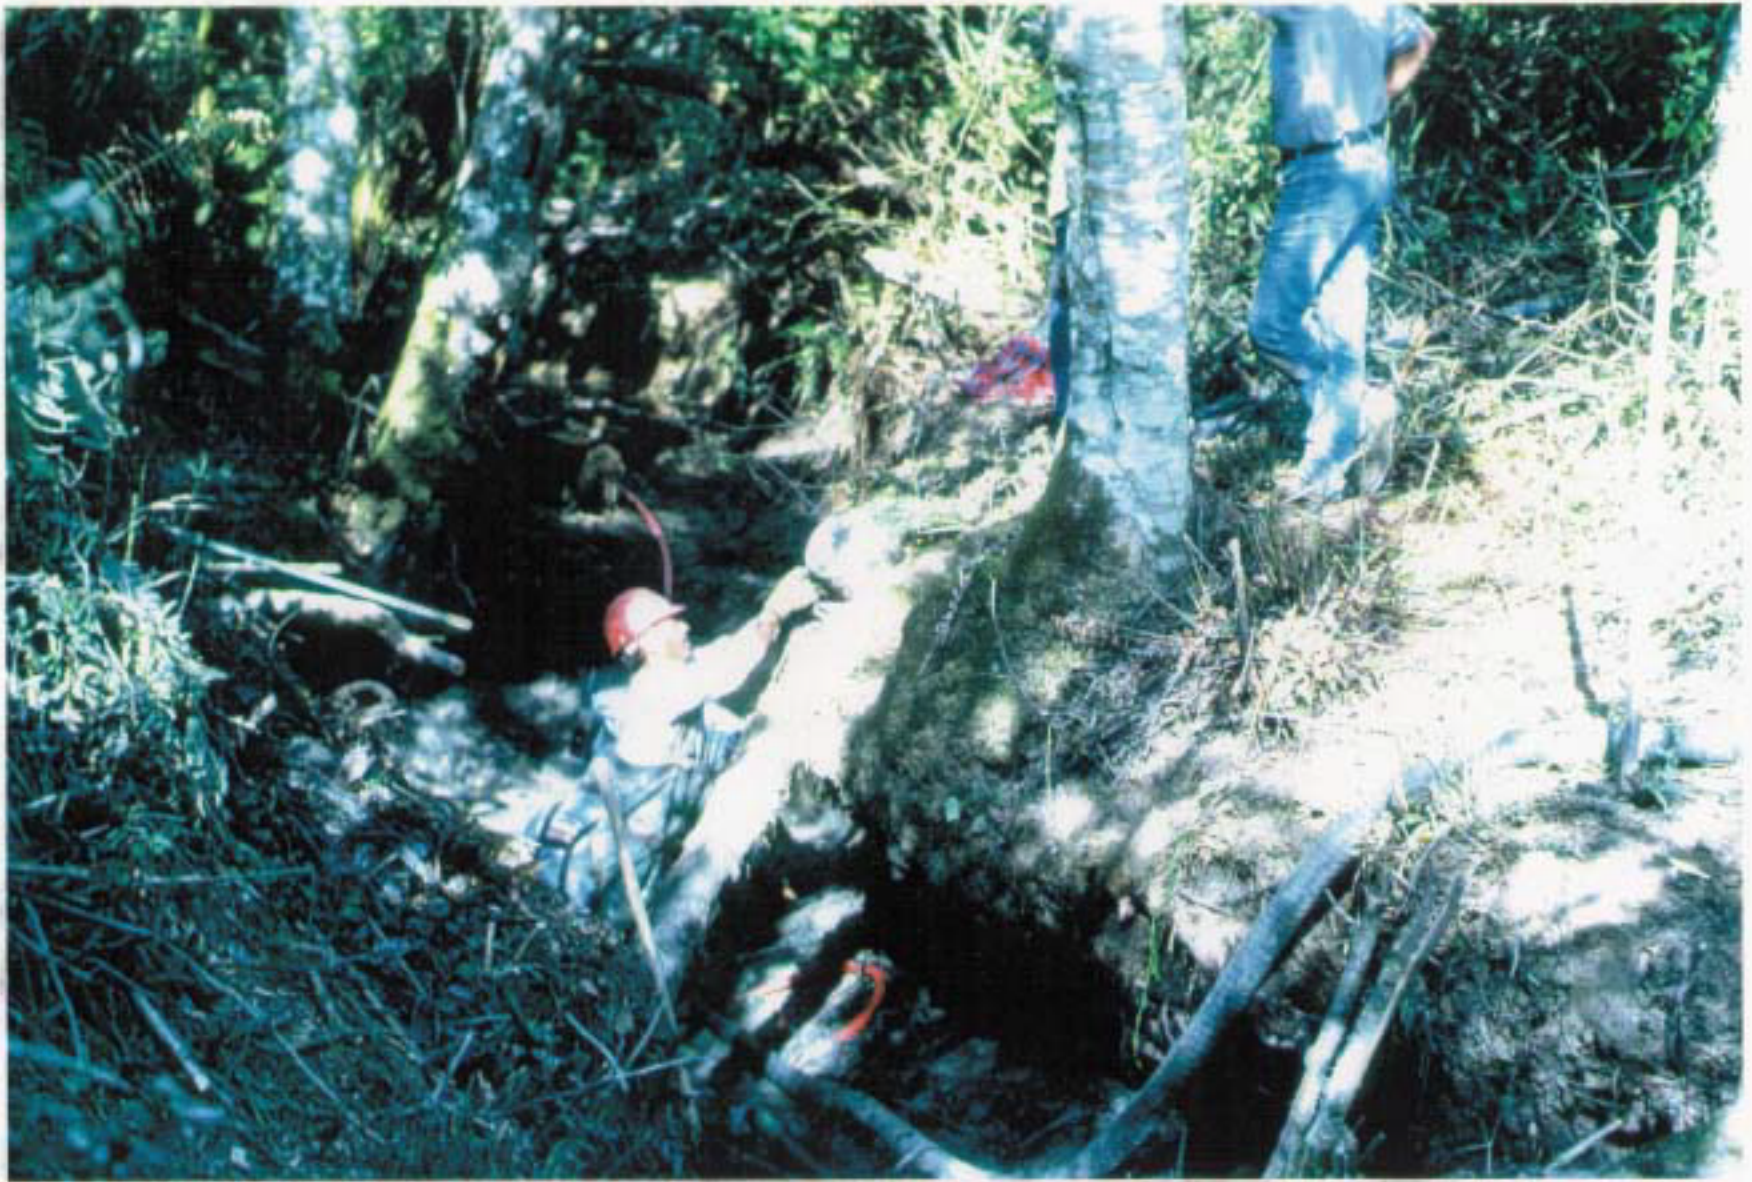
Photo #4. Crews hired by AT&T help clean the lowest reach of the Moat Creek stream channel on the Hay Ranch in August 1992.

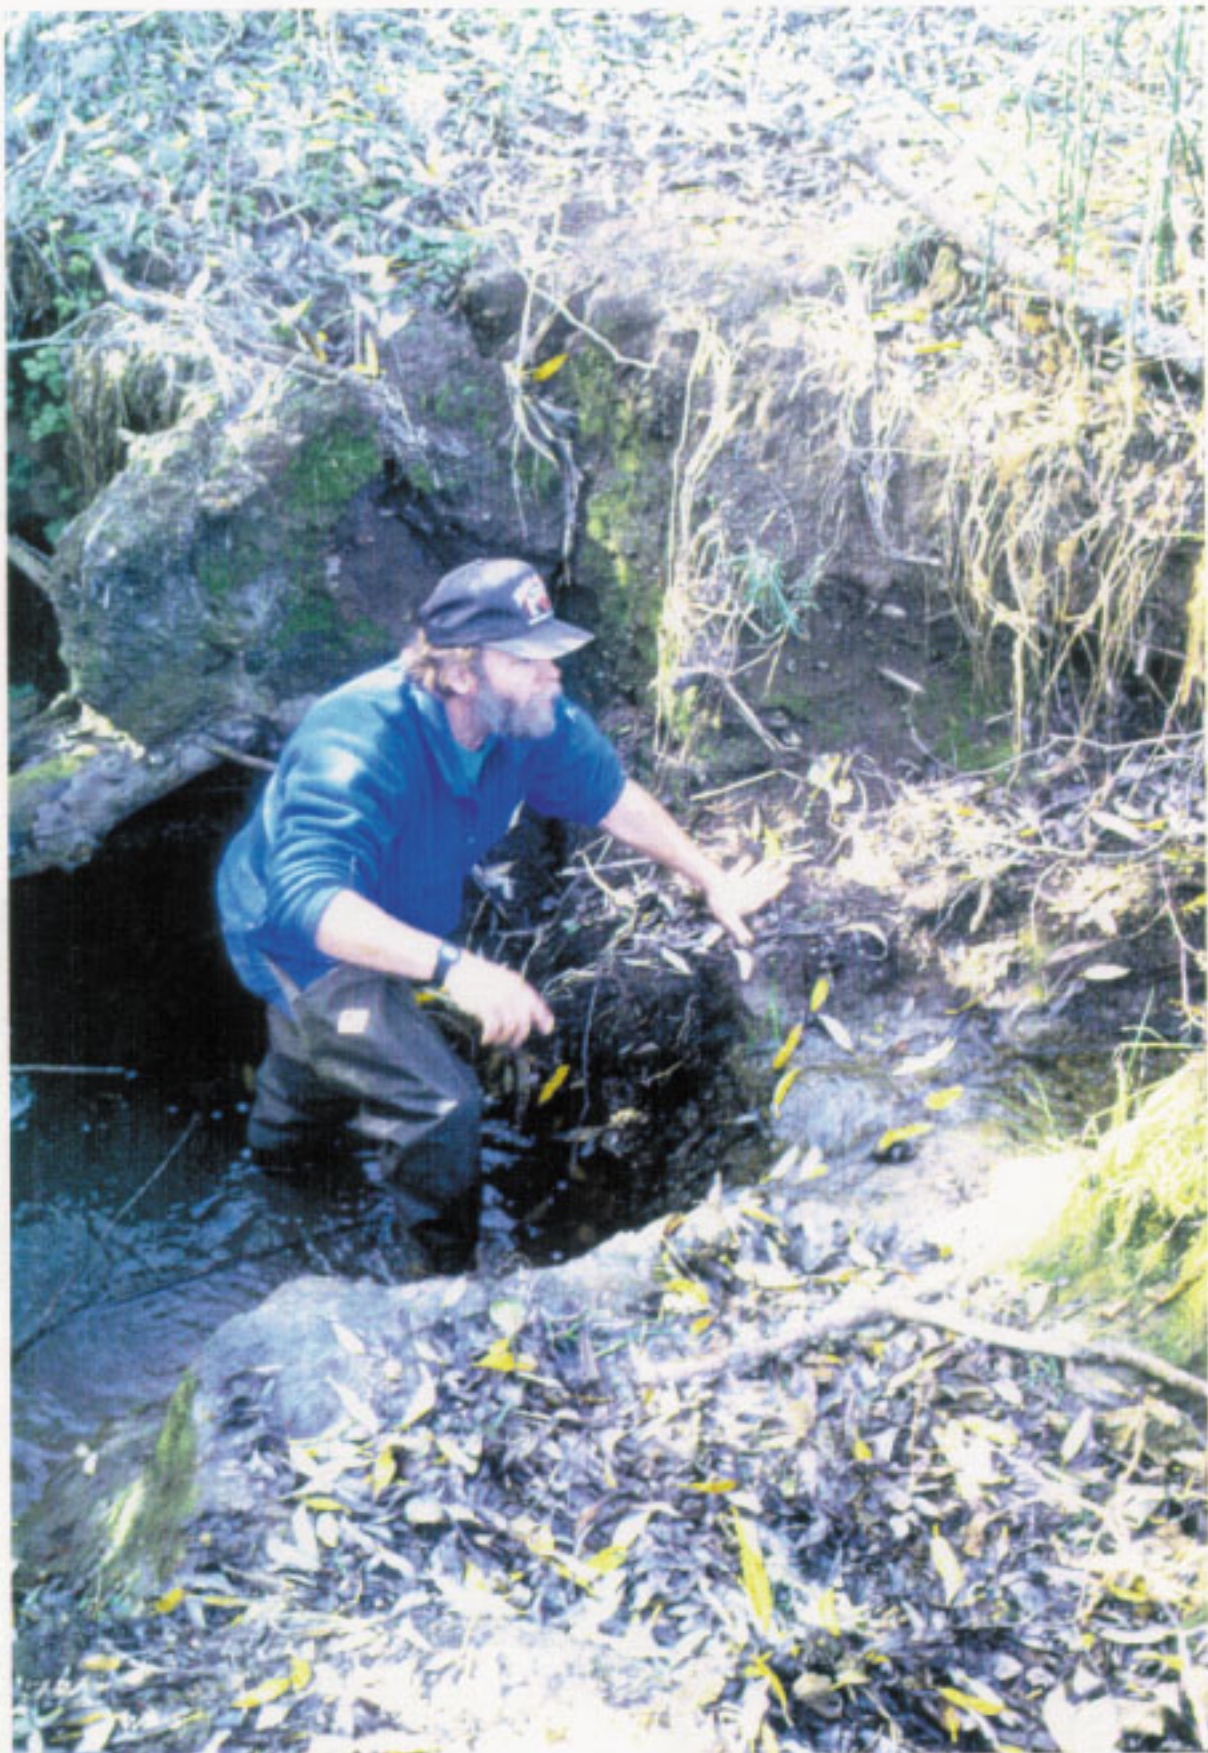
All lower reaches of Moat Creek were either clay bottomed or had a thin layer of pea gravel overlying clay (Photo #). A small amount of cobble and gravel was found in terraces, above sites where log jams had been removed down stream of Curly Lane. The jams had formerly served to trap these coarse bed materials but also fine sediment. No appropriate site for salmon or steelhead spawning was available throughout the lowest 1.75 miles of the stream. Coho salmon are not able to access steeper reaches of small streams, so the lack of spawning substrate in low gradient reaches of Moat Creek near the ocean would make the stream unsuitable for them.

During the August 6 field tour, it was noted that the stream appeared to be down cut in the reach below Curly Lane by somewhere between 15-20 feet. Pea gravels in a linear pattern were embedded in stream banks a few feet above current stream flow which also suggested down cutting. Denuded banks at an old access for stock watering led to a hypothesis that grazing practices during times of early settlement might have triggered down-cutting.

Photo #5. Geologist Danny Hagans examines signs of active down-cutting in the Moat Creek stream channel below Curly Lane. Note that the stream bed is clay at this point.

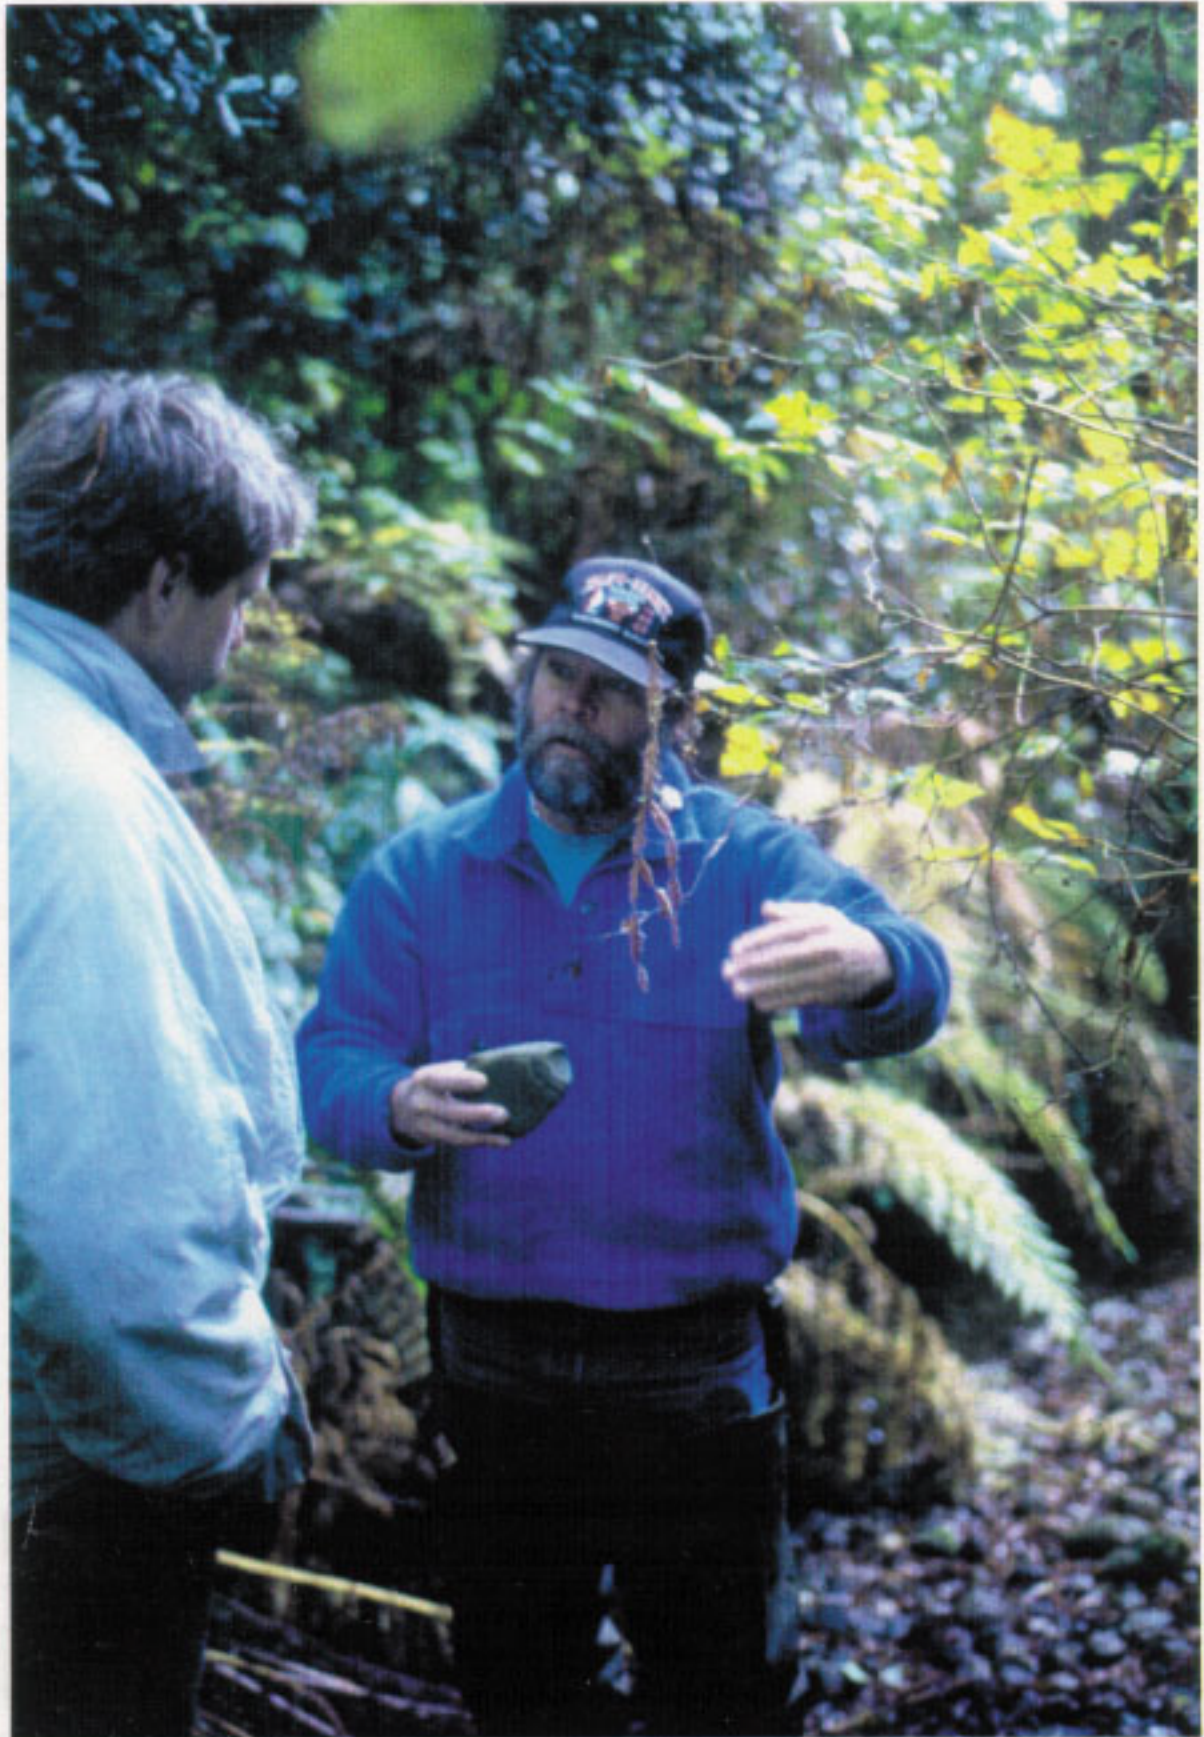
Slates, shales, siltstones and mudstones are not only soft but often have bedding characteristics that causes the materials to erode in sheets. These plate-like clasts do not transform into rounded cobbles and gravels when weathered in a stream environment. The more well consolidated sandstones in the watershed do become rounded as they wash downstream but they usually have weak bedding planes which causes them to break down (Photo #5). This explains in part why coarse bed materials were present in headwaters of Moat Creek while lacking in lower reaches; the rocks simply disintegrate as they tumble downstream. The quartz-rich pea gravels of the marine terrace deposits are really the only truly hard rock in the basin; therefore, it is not surprising that they are often the only armoring seen in lower reaches of the stream.

Photo#6. Danny Hagans shows Brian Thurmond how weak bedding planes in the sandstone bedrock of the Moat Creek watershed cause cobbles and gravels to break down as they are transported downstream.
