**Final Report**

***McCREADY GULCH FISH PASSAGE  
BARRIER REMOVAL PROJECT***

***August 2003***

**By  
Coastal Stream Restoration  
Prepared by Bob Pagliuco**

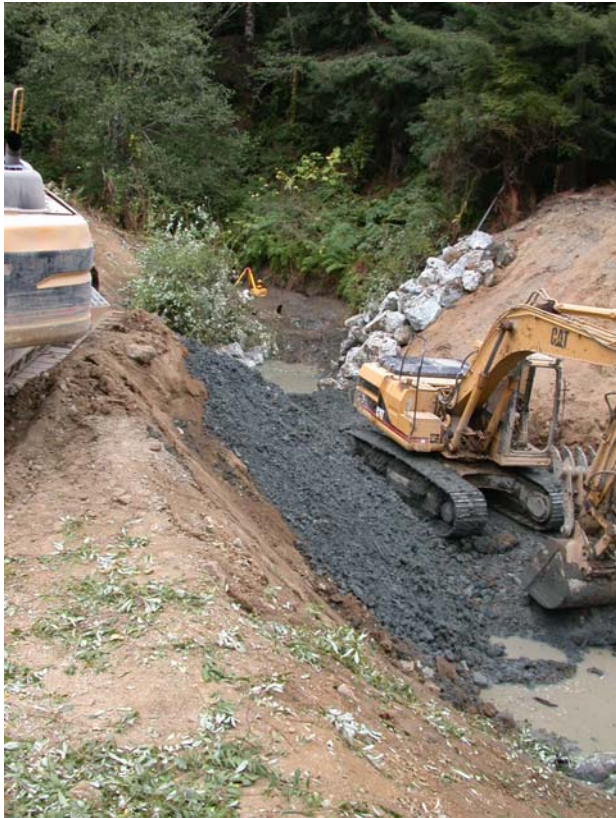
View looking upstream during project implementation. Creek flow is diverted around left bank through a hose, allowing CAT operator to work in the creek.

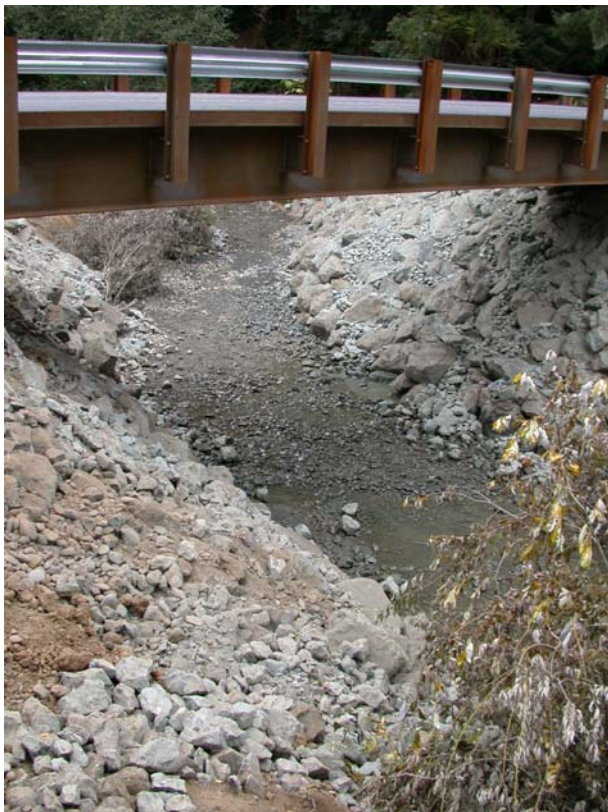
Same view as above picture, after project completion. Bridge is in place, both banks are rocky and stable, and stream flow is diverted back to main channel.

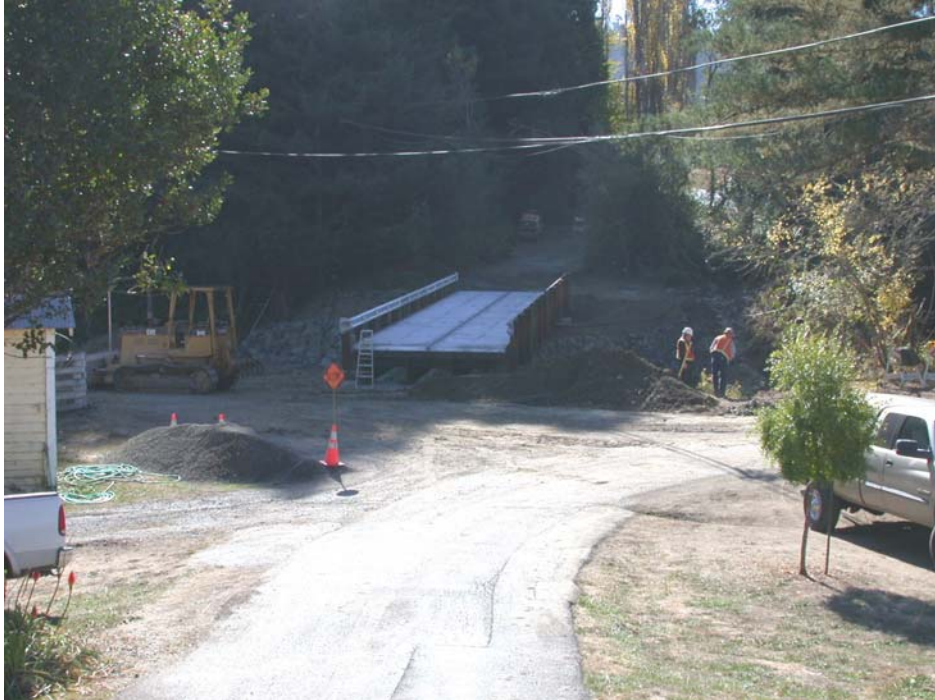
View looking from right bank to left bank after two-part bridge was set in place on concrete footings.

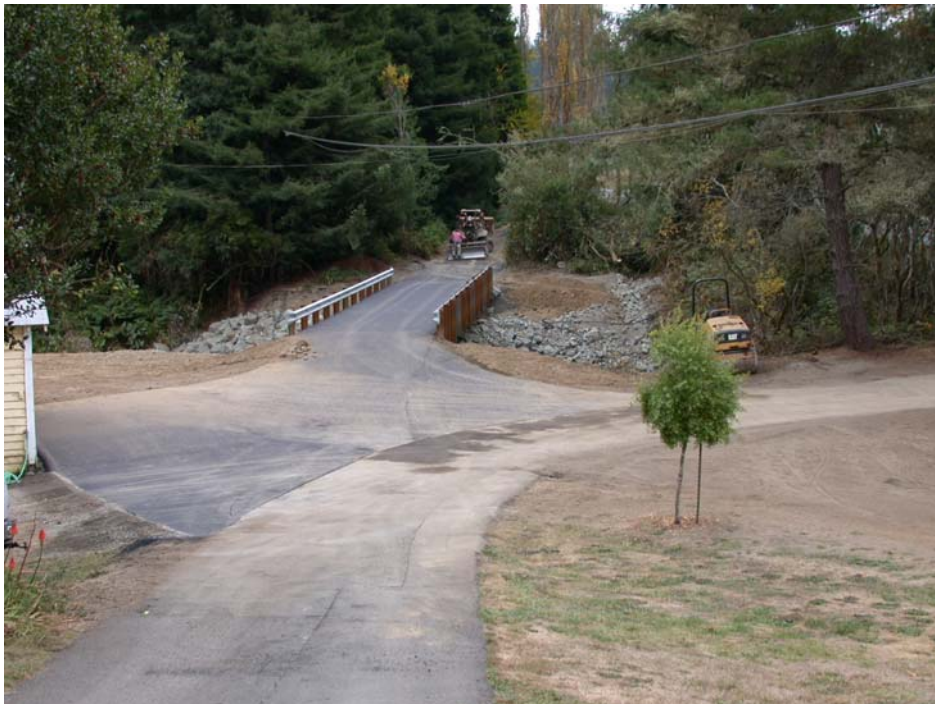
Same view as above after the banks have been rocked and mulched and the bridge has been paved.

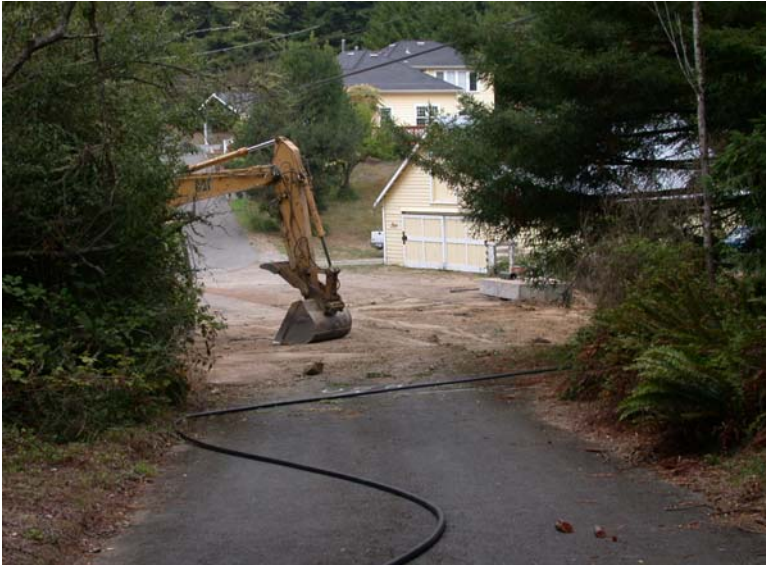
Looking from left bank to right bank, the CAT is beginning to remove the asphalt above the culvert. The entire flow of the creek is diverted using this hose lying across the driveway.

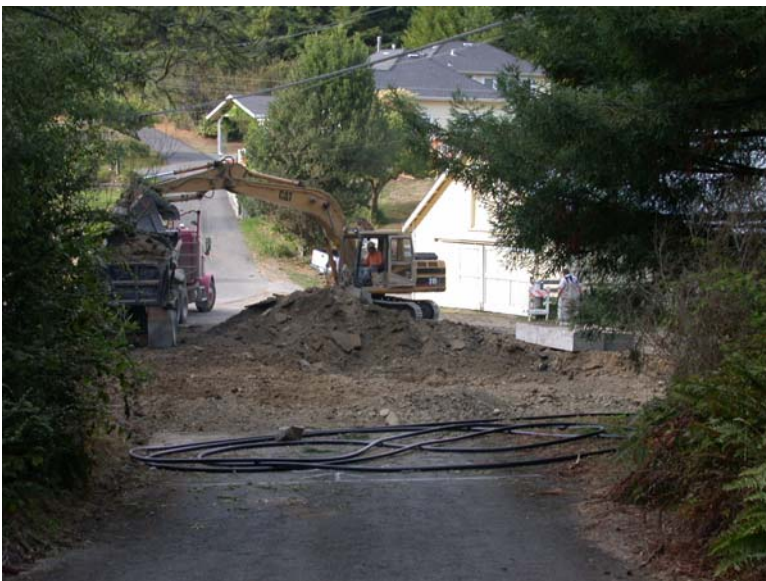
Removing fill and asphalt surrounding the box culvert.

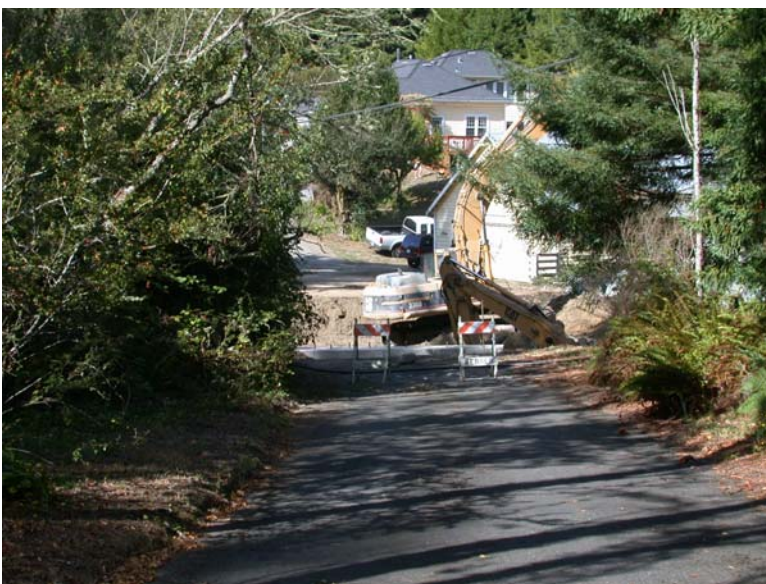
The box culvert has been removed and the banks are being re-graded.

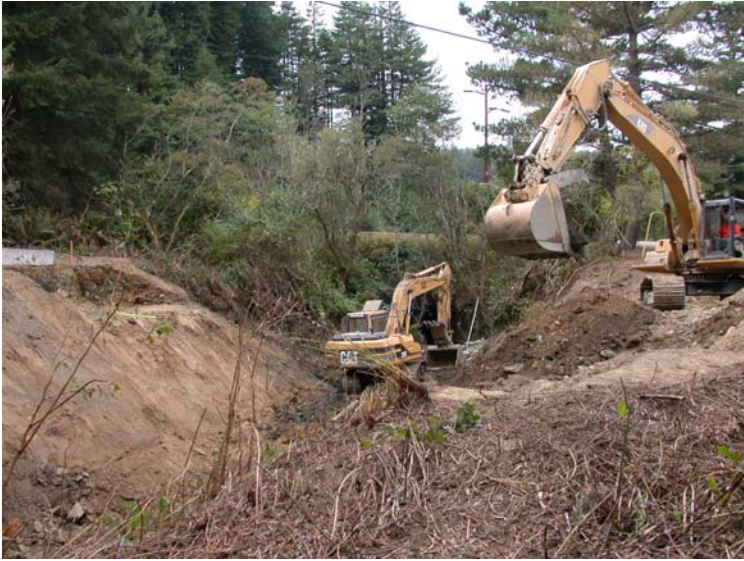
A view looking downstream at the fill being taken out of the channel and the banks being reshaped, prior to bridge installation.

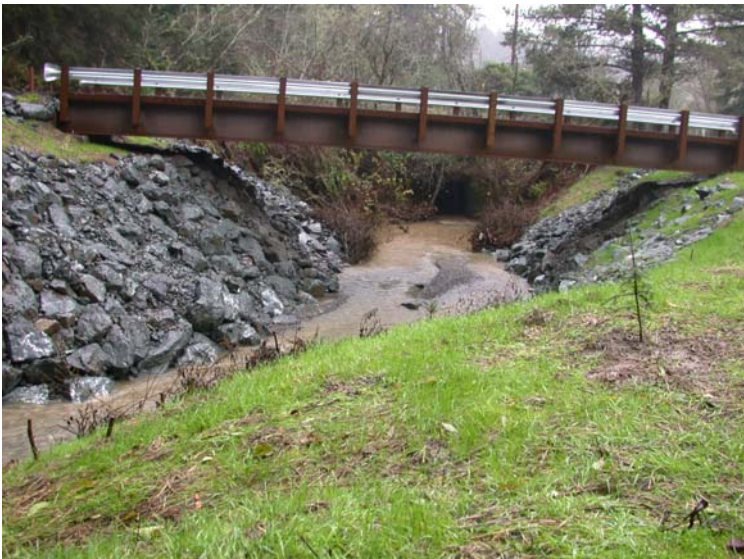
Similar view as above after bridge has been placed, banks have been reshaped, rocked, and mulched, and grass, willows, and conifers have been planted in order to re-vegetate the excavated bank .

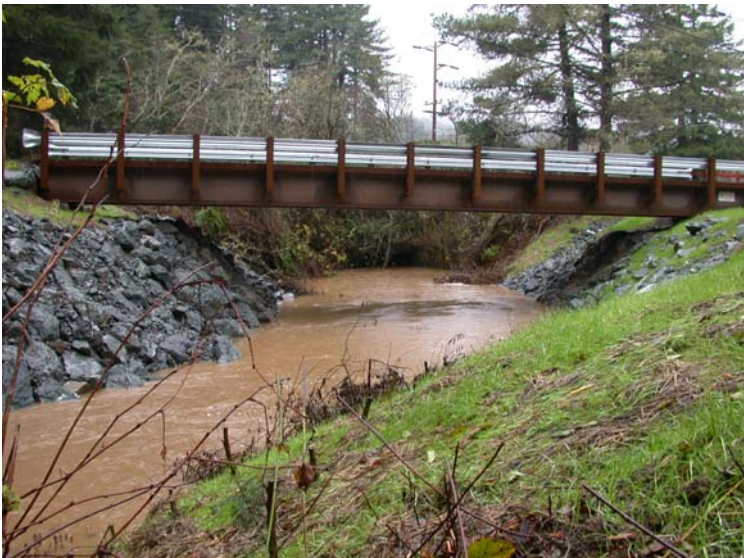
View of project site after completion in higher winter flows. Notice the willow mattress stabilizing the right bank while also trapping fine sediment.

Additional stabilization work was completed on the right upstream bank, to ensure stability during this first winter while the channel adjusts to the instream modifications. The CSRG crew cut and processed the willow necessary and constructed a willow wall revetment at the toe of the bank.

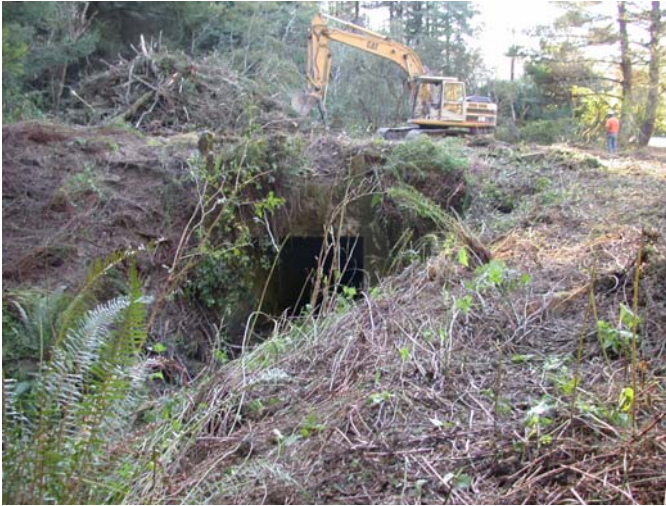
View of box culvert looking downstream while excavating the asphalt above.

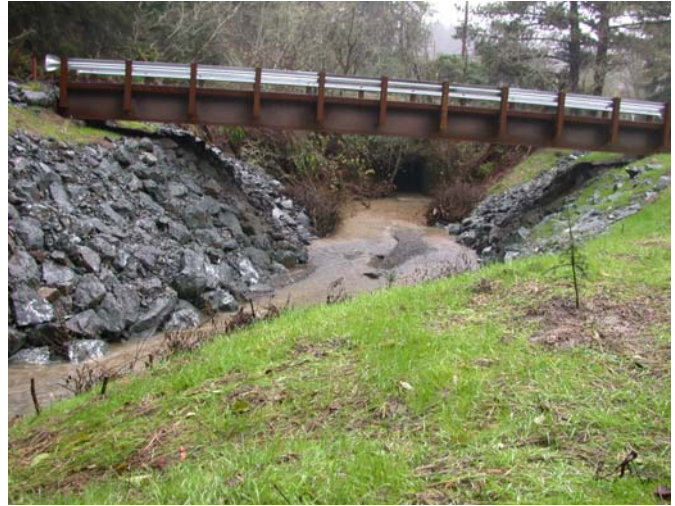
View of project site with culvert removed and bridge installed.

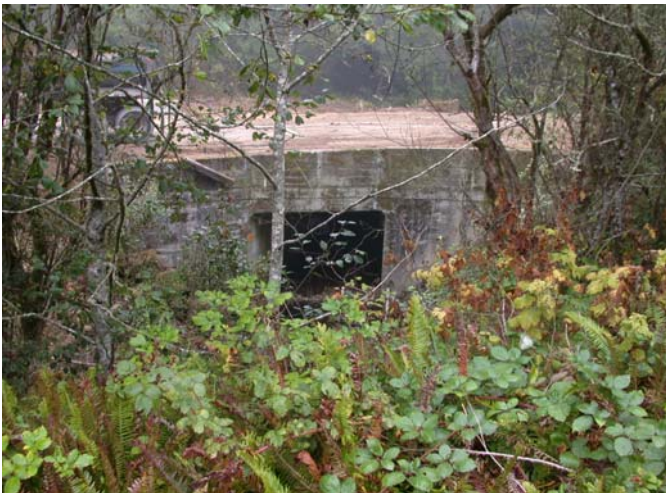
Pre-project view of box culvert looking upstream.

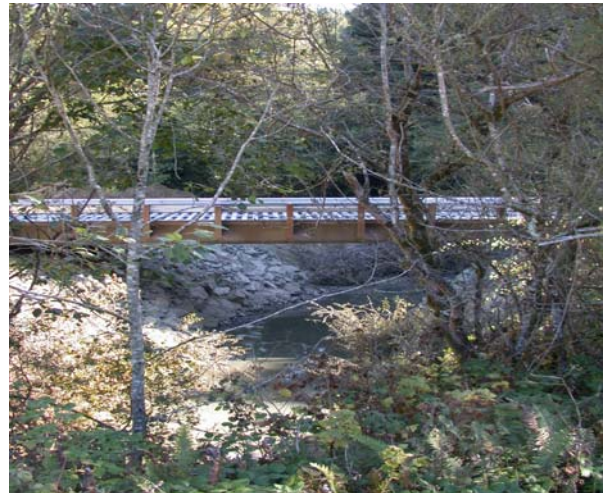
Post-project view of new bridge from same photopoint.

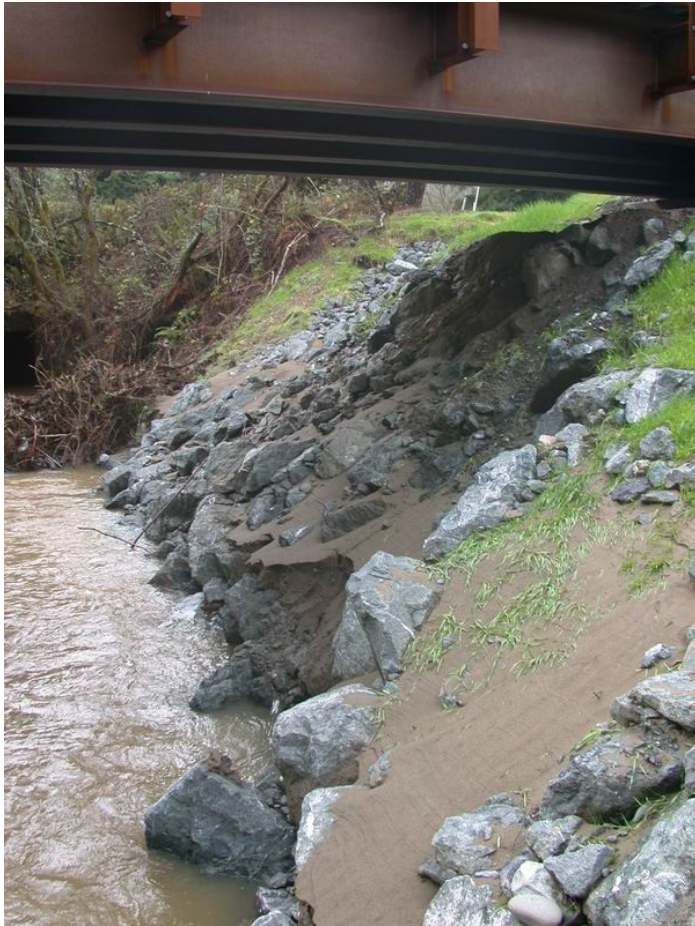
Picture looking downstream after project completion showing right bank fine sediment deposition.

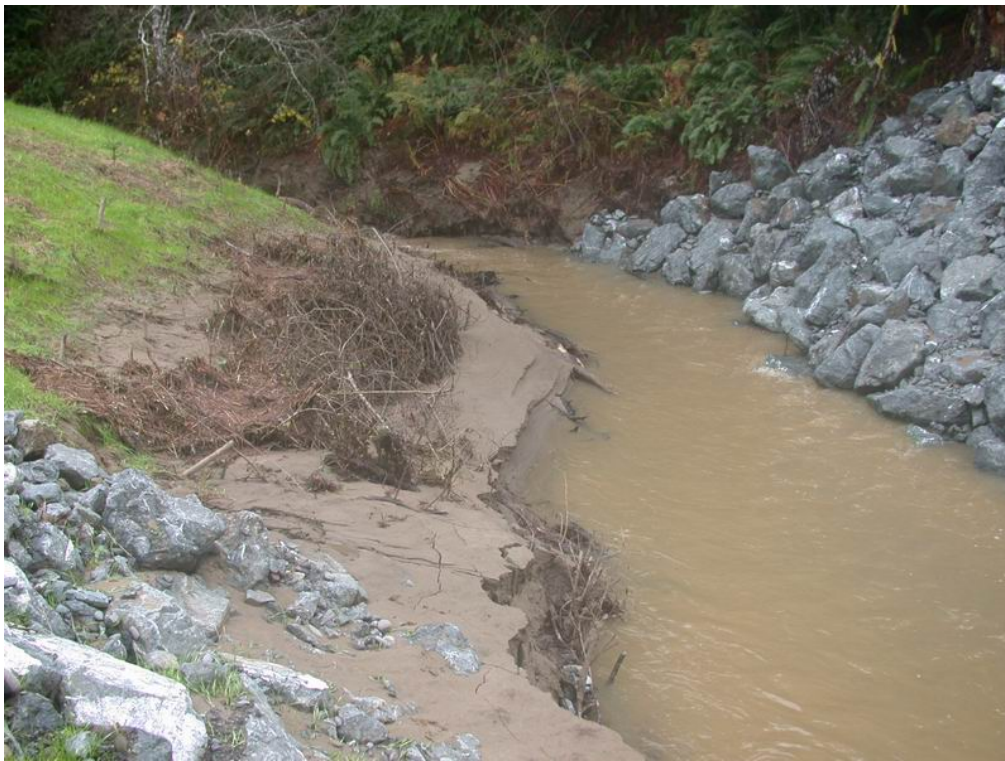
Looking 100ft downstream of bridge at sediment deposition on the willow mattress.

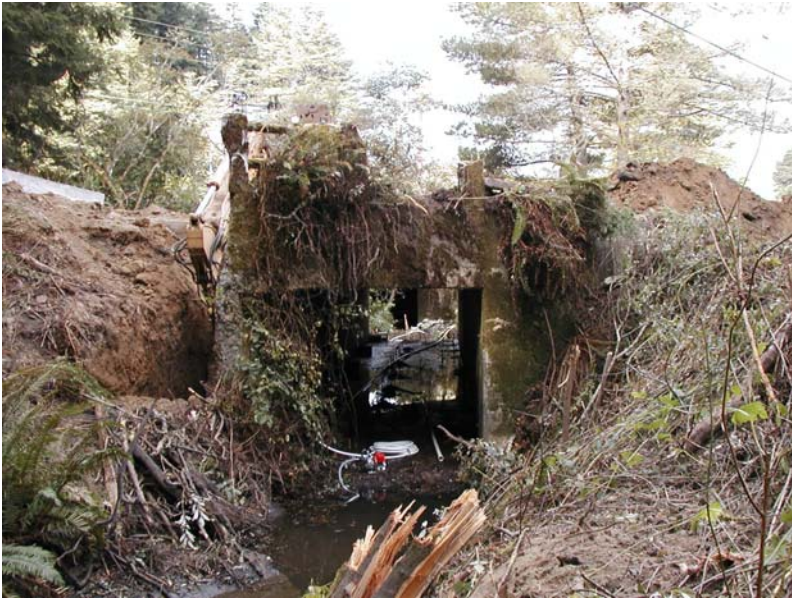
Removing the culvert, looking downstream.

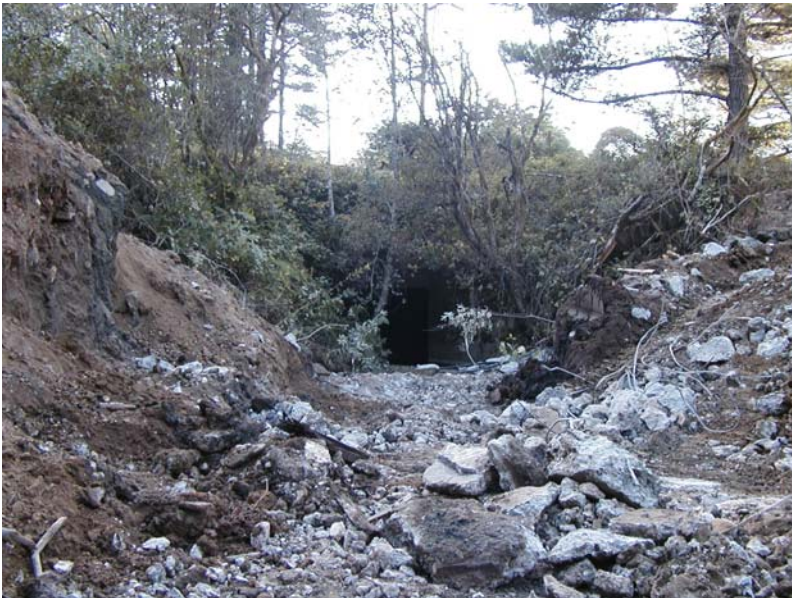
Culvert removed, looking downstream.

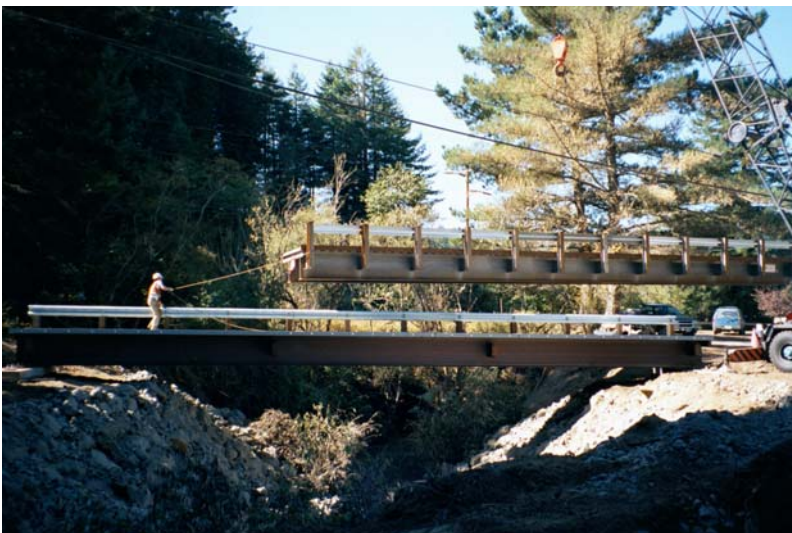
Positioning second half of bridge.

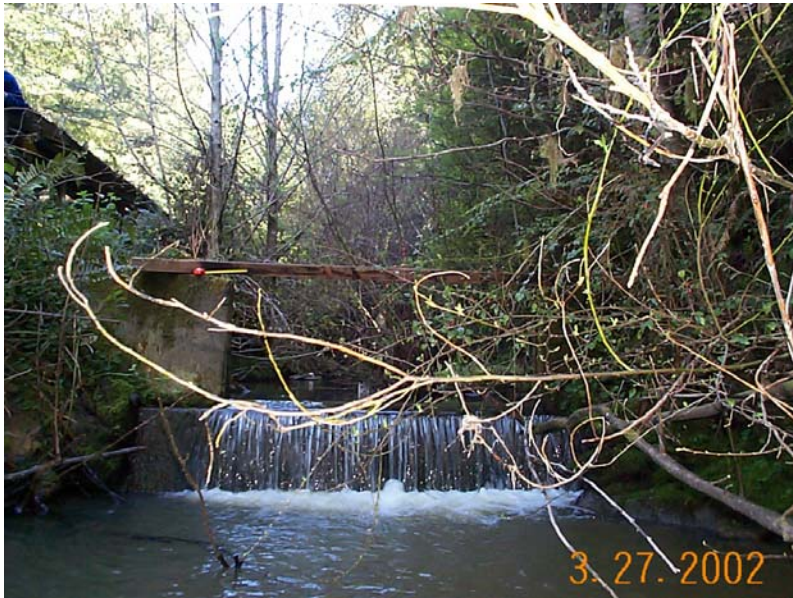
McCready dam built for water retention and diversion for the town of Freshwater's drinking supply. Photo taken pre-project looking upstream. Notice the 2.5 ft drop.

The appropriate equipment was rented, and the CSRG crew, over the course of two days, modified the concrete weirs upstream of the bridge site. These modifications should provide easier upstream fish migration under lower flows over these existing weirs. A well-attended volunteer workday was held 10/27/02 to complete the willow mattress work, rock chinking of the RSP, and cutting and planting additional willow posts. The cofferdams and screening, as well as all pumping equipment was removed 10/30/02. The W&K engineers completed a re-survey of the project site (10/31/02) for the as-built plans required by the county through their encroachment permit.

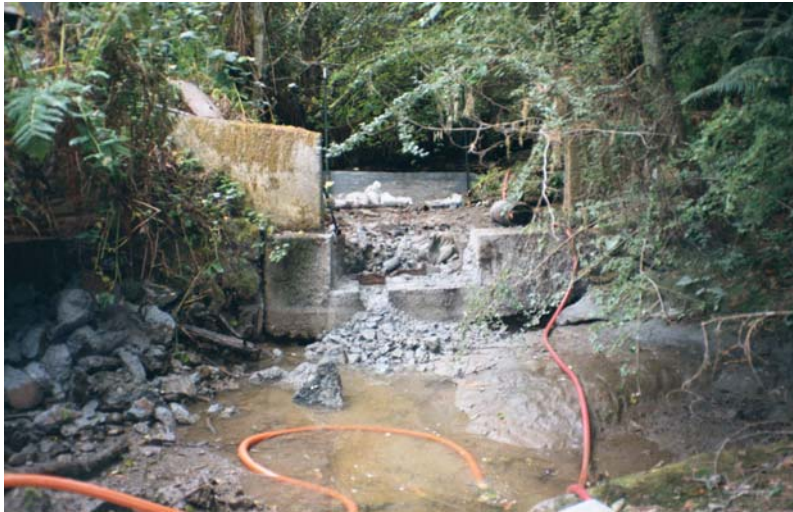
View of a notch cut in the dam to improve fish passage and slowly release sediment built up behind the dam..

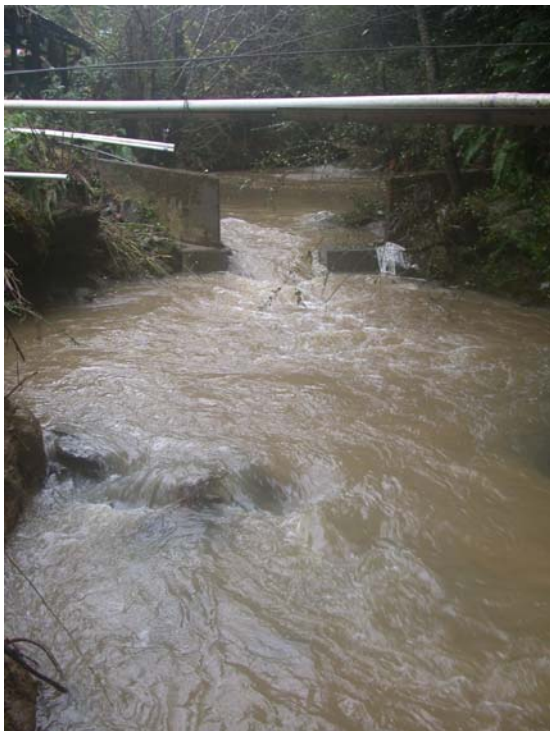
Notched dam in winter flows allowing easy migration through channel.
