# **BIOTECHNICAL BANK STABILIZATION ON THE PETALUMA RIVER, CALIFORNIA**

Eroded streambanks subjected to high energy flows can be stabilized without hard structural treatments in a manner that is compatible with habitat restoration objectives. Erosion was threatening the site for a proposed shopping mall and riparian habitat restoration project on the Petaluma River. The Petaluma River is a low gradient stream at that location, with a muted tidal influence from the San Francisco Bay, which is approximately 19 kilometers (12 miles) downstream. Despite the mild gradient and relatively low flows during the dry summer, high flows following intense winter storms have the energy to cause extreme scouring and undercutting. The City of Petaluma, 64 kilometers (40 miles) north of San Francisco, California, required a "soft" approach to achieve both erosion control and habitat mitigation objectives. The solution included installation of 0.3 meter (12 inch) diameter coconut fiber cylinders in rows on contour to provide protection to the toe of slope. The upper bank was secured by rows of live willow wattling (cuttings in bundles) staked to form linear rows. Areas in between the rows of wattli

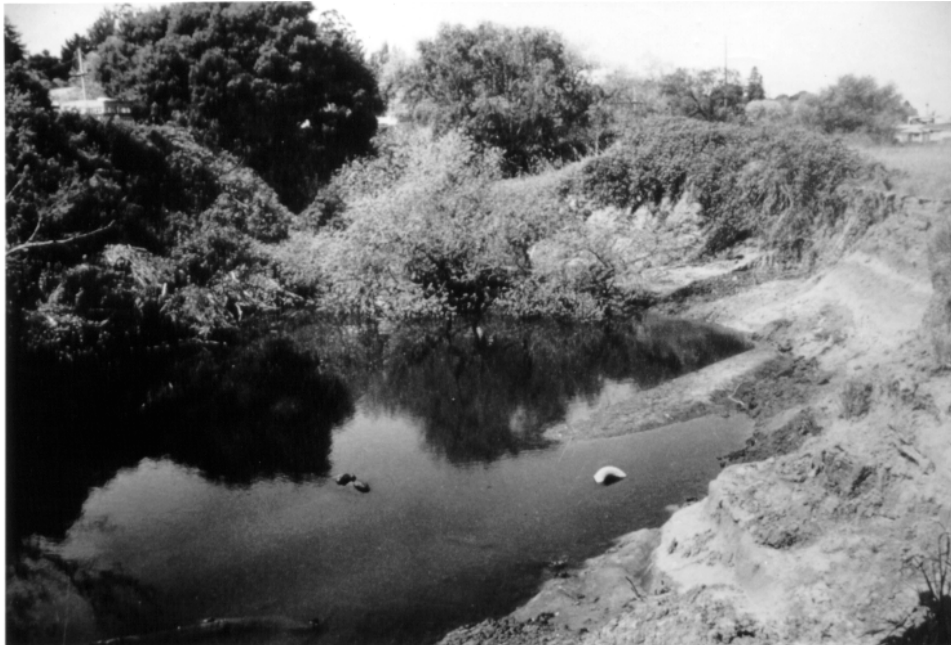
The Petaluma River has flooded repeatedly, both upstream and downstream of the site, with large floods causing evacuation of portions of the City in 1982 and 1986. High flows in the Petaluma River in February 1993 undercut about 91 linear meters (300 linear feet) along the riverbank, causing a large willow tree to fall in the channel. Subsequent flows were diverted by the obstruction towards the bank downstream, resulting in further undercutting and sloughing. The result was a loss of several meters horizontally from the top of bank into the project area and a steep, barren, and unstable slope (Figure 1). Further erosion of the unstable bank would eliminate a required setback from the proposed parking lot for the mall and reduce the area for riparian habitat restoration that was needed as mitigation for the project. Other areas along the project riverbank were also unstable and showed evidence of less severe undercutting. Additional concerns focused on the stability of the bank to support a proposed bridge. A purely biotechnical approach without use of structures or riprap was required by the City of Petaluma to achieve both erosion control and habitat restoration objectives without the need for an individual Clean Water Act, Section 404 permit, which would have disrupted project schedules. Based on information from a consulting hydrologist, treatments needed to be designed to withstand velocities up to 3.7 meters (12 feet) per second.

**Figure 1. Severely eroded riverbank on the Petaluma River, California, prior to treatment, with fallen willow tree in background center (May 1993).**

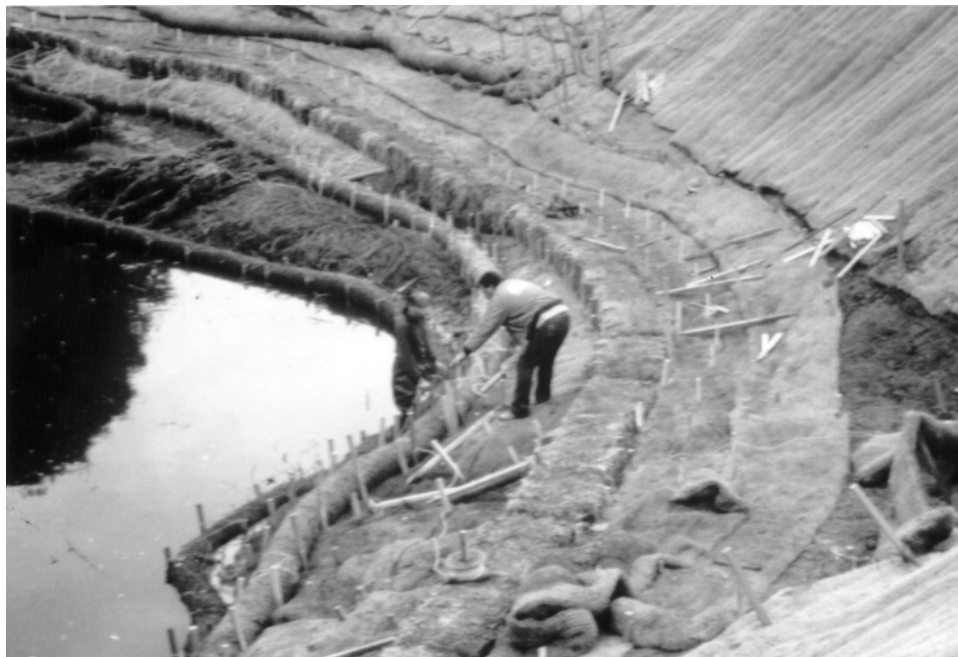
**Figure 3. Installation of coconut fiber rolls and carpets secured with "two-by-four" stakes and polypropylene cord (October 1993).**

of the vertical portions of the top of bank using a backhoe to create a more gradual slope (1:1 to 1.5:1) for improved stability and larger planting area. A row of hay bales was staked along the lower bank prior to grading as a sediment trap which prevented any soil from falling in the river. A biologist constantly monitored construction to ensure equipment stayed within construction limits and that sedimentation was minimized. The coconut fiber rolls were installed (Figure 3) securely with wooden stakes cut diagonally from 1.2 meter (4 foot) to 1.8 meter (6 foot) long construction lumber measuring about 5 centimeters thick by 10 centimeter wide ("two-by-fours"). The rolls were anchored by a network of polypropylene cords attached to notches in the stake and then hammered down taut with the surface. The upper bank was protected with rows of wattling trenched in on contour and wedged in with wooden stakes. An Abney level was used at frequent intervals during installation of the wattling and the fiber rolls to ensure they were placed on contour. This is important to prevent accumulation of water resulting in breaching of low spots. Areas between the fiber rolls and wattling were staked and tied down with coir mattresses also manufactured by Bestmann and called "Plant Carpets"®. These are 5.1 centimeter (2 inch) thick, 5 meter (16.5 feet) long, and

0.9 meters (3 feet) wide, each weighing 32 kilograms per cubic meter (2 pounds per square foot) when moist. Areas less severely undercut and the bridge abutment areas were treated with a single fascine row slightly below the low flow water line. In addition, willow wattling and Plant Carpets® were installed to stabilize disturbed areas under the bridge abutment. Installation was completed by the middle of November 1993.

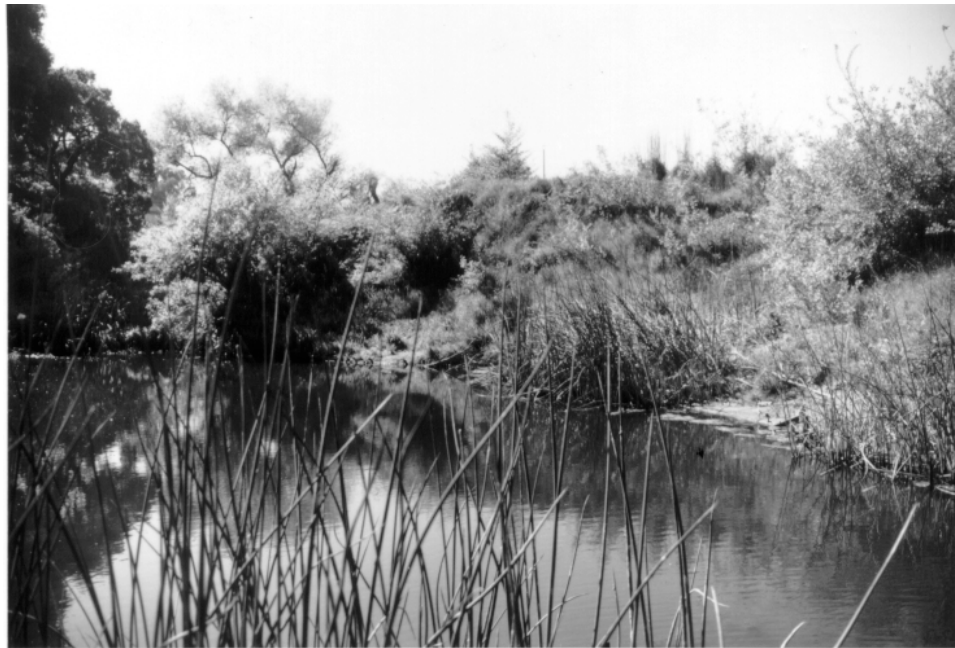
**Figure 4. The previously unstable eroded riverbank has been secured and is densely covered with native riparian vegetation (July 1997).**

high flows over the top of bank and inundated the mall's parking lot, which was designed as a flood detention basin. Some undercutting and sloughing occurred on adjacent untreated riverbanks, but the treated areas remained intact with no damage. Although the project team was pleased with the results, there was more of a test to come. Another flood, this one even more severe, hit the Petaluma River in early March 1995. Again, the bank was overtopped and the parking lot flooded. Post flood inspections revealed that the site was still intact, except for a small slide that was repaired easily. The site has withstood five rainy seasons (including this winter) with moderate to severe flooding. The previously eroded bank is densely covered with native emergent wetland and woody riparian vegetation (Figure 4). The adjacent recreational assets and property values have been protected, and a major source of sedimentation to the San Francisco Bay has been stabilized. Observations of wildlife use have demonstrated that a previously eroding riverbank with low scenic and wildlife values has been not only stabilized but restored to a viable native riparian habitat. This project is living proof that biotechnical approaches to erosion control in dynamic high energy river systems are feasible and can provide high levels of protection, while not only sparing damage to habitat values but actually enhancing them.
