Appendix A

Location of Transects, Study Sections,
Instream Structures and U.S. Geological Survey Gage Stations
-Russian River and Lower Dry Creek

Appendix B

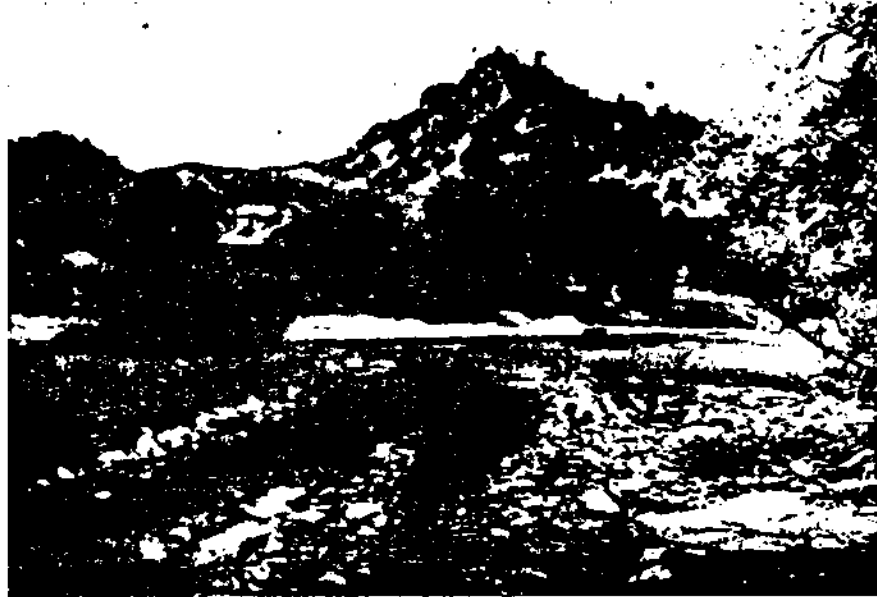
Location: Russian River Mile 67 Observed Flow (cfs) 238

Cross Channel Width (Feet)	<u>240</u>			
Bridge Width (Feet)	<u>bridge not installed*</u>			
Bridge Height Above Water Surface (Feet)	<u>N/A</u>			
Number of Channels	<u>N/A</u>			
Channel Information	<table border="0" style="width: 100%;"> <tr> <td style="width: 40%;">Width (Feet)</td> <td style="width: 20%;">Depth (Feet)</td> <td style="width: 40%;">Surface Velocity (FPS)</td> </tr> </table>	Width (Feet)	Depth (Feet)	Surface Velocity (FPS)
Width (Feet)	Depth (Feet)	Surface Velocity (FPS)

Impounded Water Surface Width (Feet)	<u>N/A</u>
Flowing Water Surface Width (Feet)	<u>240</u>

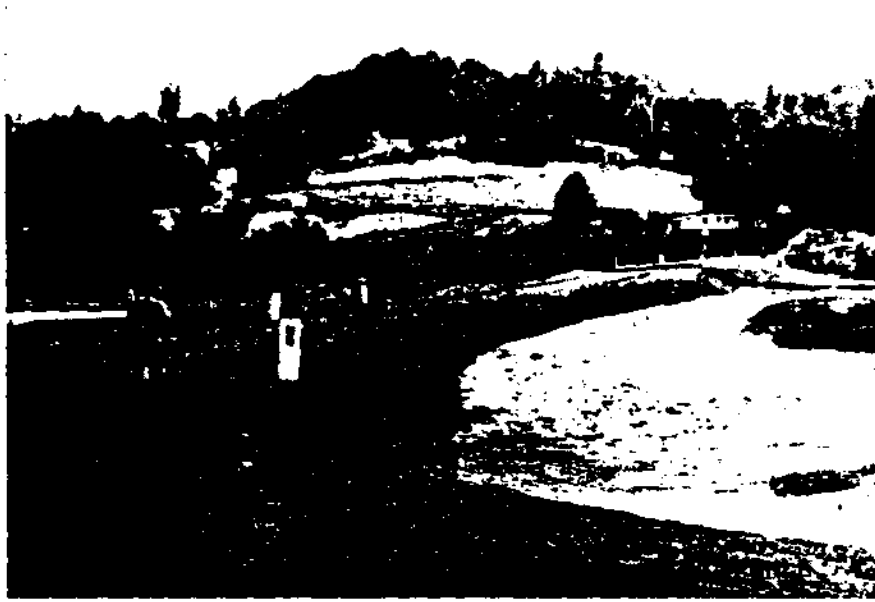
Structure- Asti Summer Road Crossing Date of Observation 7/26
 Location- Russian River Mile 56 Observed Flow (cfs) 214

Cross Channel Width (Feet)	<u>570</u>		
Bridge Width (Feet)	<u>60</u>		
Bridge Height-Above Water Surface (Feet)	<u>4</u>		
Number of Channels	<u>3</u>		
Channel Information	Width (Feet)	Depth (Feet)	Surface Velocity (FPS)
Left channel	18.0	1.0	1.62
Middle channel	18.0	4.0	3.05
Right channel	18.0	2.0	1.18

Impounded Water Surface Width (Feet) (no impounded water)
 Flowing Water Surface Width (Feet) 54

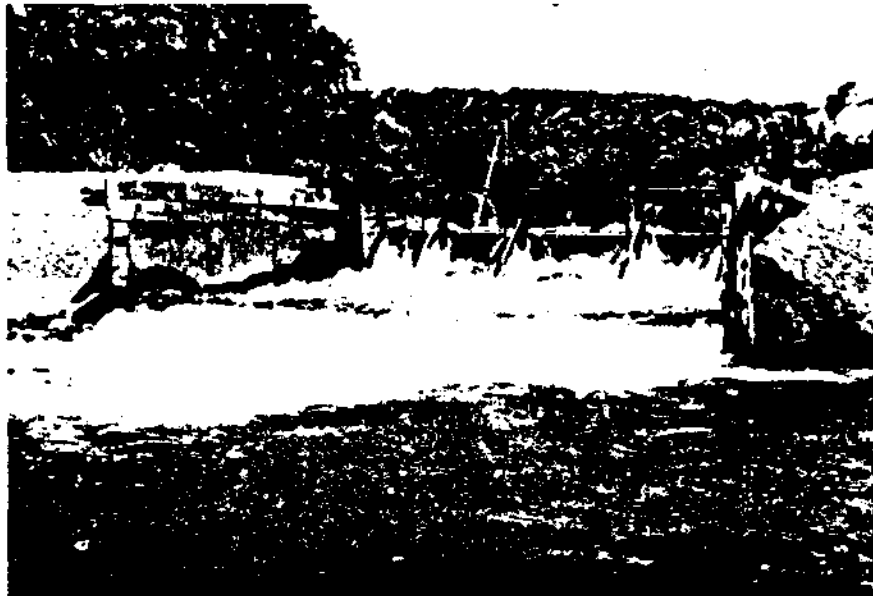
Observed Flow (cfs) 198

Cross Channel Width (Feet)	<u>160</u>
Dam Height (Feet)	<u>12.0</u>
Spillway Width (Feet)	<u>30</u>
Spillway Height (Feet)	<u>7.0 (in steps)</u>
Spillway Thickness (Feet)	<u>38.0</u>
Depth of Water over Spillway (Feet)	<u>1.5</u>
Spillway Velocity (Surface)	<u>7.0 FPS (estimate)</u>
Plunge Pool Depth (Feet)	<u>3.5</u>
Maximum Depth Behind Dam (Feet)	<u>11.0 (maximum)</u>
Jumping Distance (vertical-water surface at spillway to water surface below spillway)	<u>2.7 ft. (maximum)</u>

Water Quality Information	Upstream	Downstream
Turbidity (NTU)	<u>0.7</u>	<u>0.9</u>
Dissolved Oxygen (ppm)	<u>10.2</u>	<u>10.0</u>
Temperature (°C) at Time of Day Taken	<u>22.0@1140</u>	<u>22.0@1140</u>

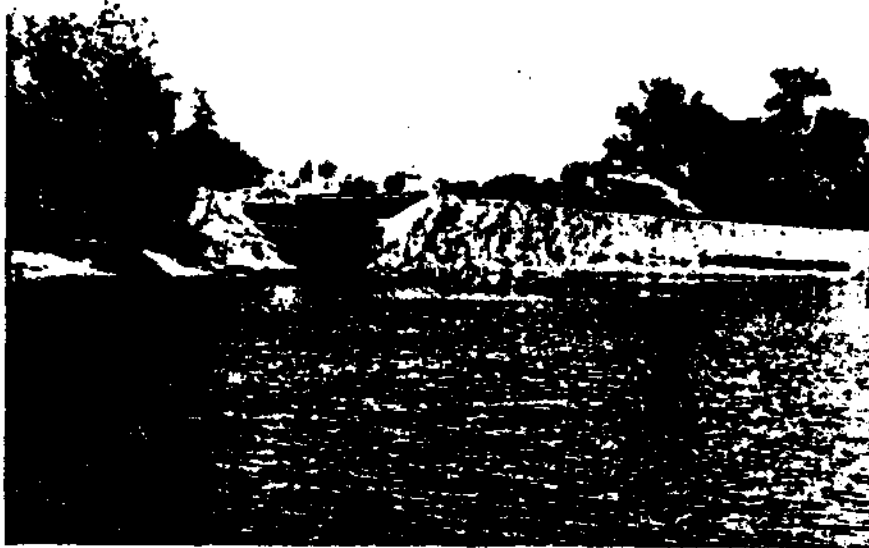
Structure- Basalt Summer Road Crossing Date of Observation 7/9/78
 Location- Russian River Mile 31 Observed Flow (cfs) 196

Cross Channel Width (Feet)	<u>424</u>		
Bridge Width (Feet)	<u>50</u>		
Bridge Height-Above Water Surface (Feet)	<u>19.2</u>		
Number of Channels	<u>2</u>		
Channel Information	Width (Feet)	Depth (Feet)	Surface Velocity (FPS)
Left channel	21.0	3.9	3.26
Right channel	21.0	3.5	3.26

Impounded Water Surface Width (Feet)	<u>424</u>
Flowing Water Surface Width (Feet)	<u>42</u>

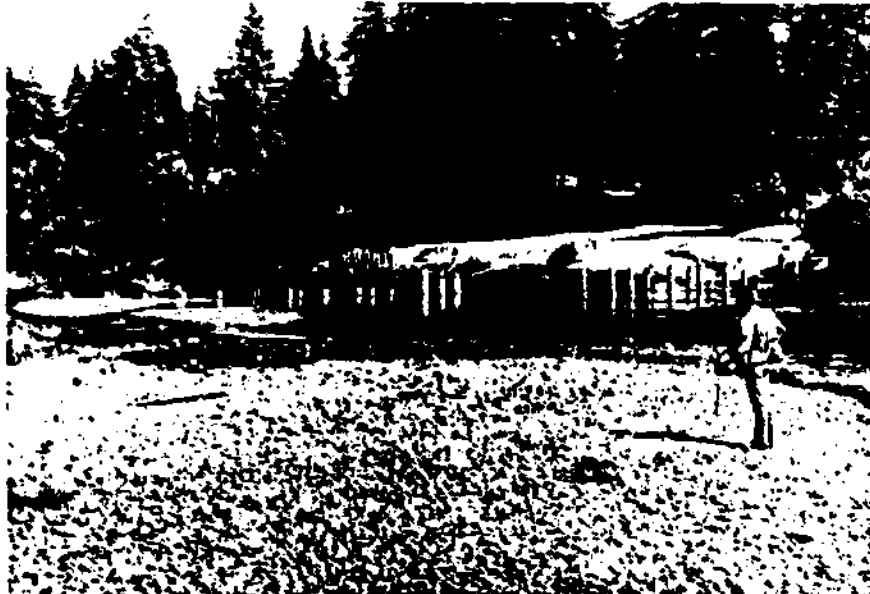
Location- Russian River Mile 22

Cross Channel Width (Feet)	_____	No Data Taken - No Longer an Impoundment
Dam Height (Feet)	_____	
Spillway Width (Feet)	_____	
Spillway Height (Feet)	_____	
Spillway Thickness (Feet)	_____	
Depth of Water over Spillway (Feet)	_____	
Spillway Velocity (Surface)	_____	
Plunge Pool Depth (Feet)	_____	
Maximum Depth Behind Dam (Feet)	_____	
Jumping Distance (vertical-water surface at spillway to water surface below spillway)	_____

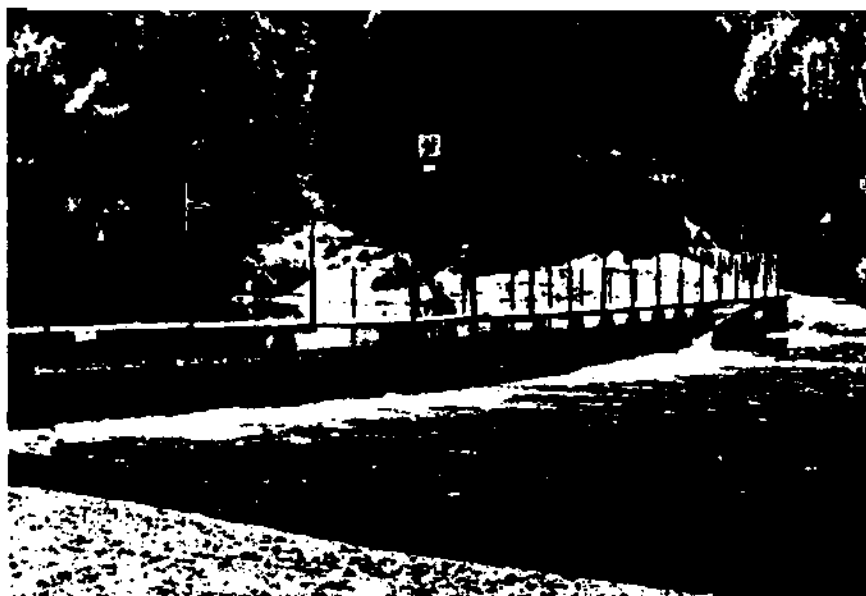
Observed Flow (cfs) 123

Cross Channel Width (Feet)	<u>210</u>	
Dam Height (Feet)	<u>8.0</u>	
Spillway Width (Feet)	<u>180</u>	
Spillway Height (Feet)	<u>7.0</u>	
Spillway Thickness (Feet)	<u>0.5 (Flashboards)</u>	
Depth of Water over Spillway (Feet)	<u>1.0</u>	
Spillway Velocity (Surface)	<u>Freefall</u>	
Plunge Pool Depth (Feet)	<u>5.0</u>	
Maximum Depth Behind Dam (Feet)	<u>6.8</u>	
Jumping Distance (vertical-water surface at spillway to water surface below spillway)		<u>Denil Fishway</u>

Water Quality Information	Upstream	Downstream
Turbidity (NTU)	<u>4.6</u>	<u>4.8</u>
Dissolved Oxygen (ppm)	<u>11.0</u>	<u>9.3</u>
Temperature (°C) at Time of Day Taken	<u>24.0 @0930</u>	<u>23.0 @0930</u>

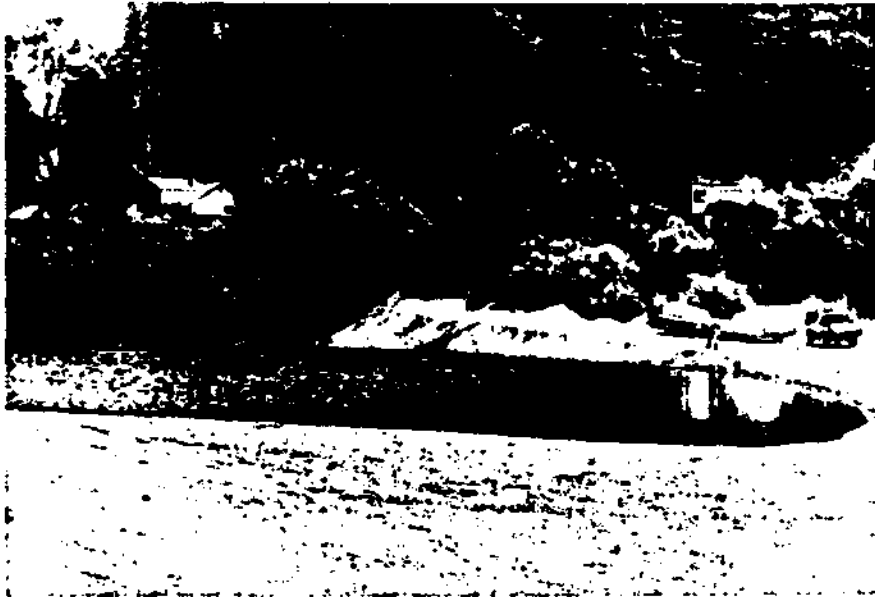
Date of Observation 7/25/78
Observed Flow (cfs) 123

Cross Channel Width (Feet)				<u>539</u>
Bridge Width (Feet)				<u>100</u>
Bridge Height-Above Water Surface (Feet)				<u>9.0 to 12.0</u>
Number of Channels				<u>5</u>
Channel Information	Width (Feet)	Depth (Feet)	Surface Velocity (FPS)	
(Left channel) 1	32.0	5.0	0.82 (average)	
2	16.0	9.0		
3	16.0	7.0		
4	16.0	3.7		
5	16.0	2.0		
Impounded Water Surface Width (Feet)				<u>395</u>
Flowing Water Surface Width (Feet)				<u>96</u>
Water Quality Data	Upstream	@ Structure	Downstream	
Turbidity (NTU)	<u>4.6</u>	<u>5.6</u>	<u>4.9</u>	
Dissolved Oxygen (ppm)	<u>9.3</u>	<u>9.3</u>	<u>9.9</u>	
Water Temperature (°C) at Time of Day Taken	<u>24.5 @1200</u>	<u>24.5 @1200</u>	<u>24.5 @1200</u>

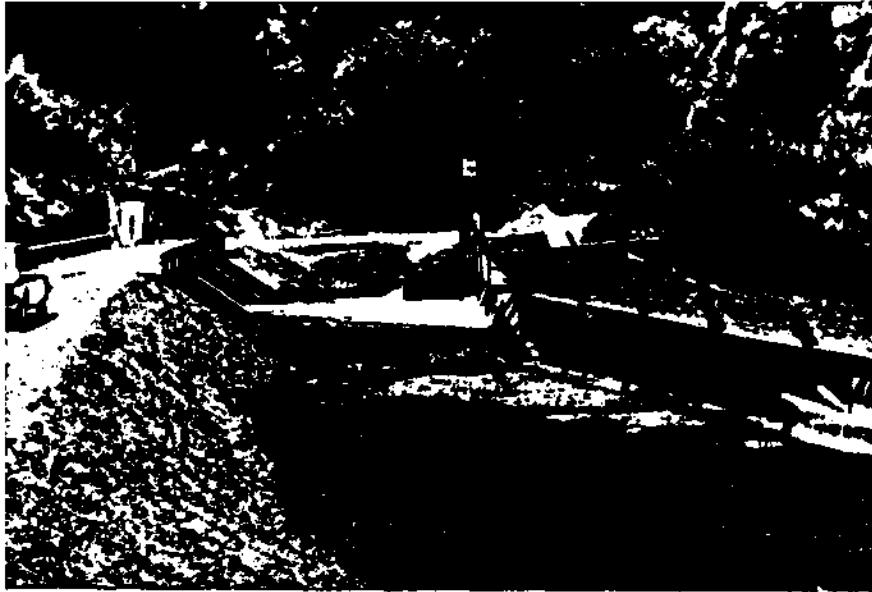
Observed Flow (cfs) 123

CONSTRUCTION Permanent concrete foundation with wooden
flashboards on hinges that are raised and
supported by steel I beams during summer months.
Dam is constructed by Russian River Parks and
Recreation District.

Cross Channel Width (Feet)	<u>270</u>	
Dam Height (Feet)	<u>8.1</u>	
Spillway Width (Feet)	<u>40</u>	
Spillway Height (Feet)	<u>7.1</u>	
Spillway Thickness (Feet)	<u>0.5 (Flashboards)</u>	
Depth of Water over Spillway (Feet)	<u>1.0</u>	
Spillway Velocity (Surface)	<u>Freefall</u>	
Plunge Pool Depth (Feet)	<u>3.0</u>	
Maximum Depth Behind Dam (Feet)	<u>7.0</u>	
Jumping Distance (vertical-water surface at spillway to water surface below spillway)		<u>Denil Fishway</u>

Water Quality Information	Upstream	Downstream
Turbidity (NTU)	<u>4.9</u>	<u>4.7</u>
Dissolved Oxygen (ppm)	<u>9.9</u>	<u>10.2</u>
Temperature (°C) at Time of Day Taken	<u>26.0@1350</u>	<u>26.0@1350</u>
