COMPLIANCE REPORT
MUDDY HOLLOW CULVERT REMOVAL
FILE NUMBER 25358N

Submitted by the National Park Service
Point Reyes National Seashore
Point Reyes Station, California, 94956

COMPLIANCE REPORT – MUDDY HOLLOW CULVERT REMOVAL – FILE # 25358N

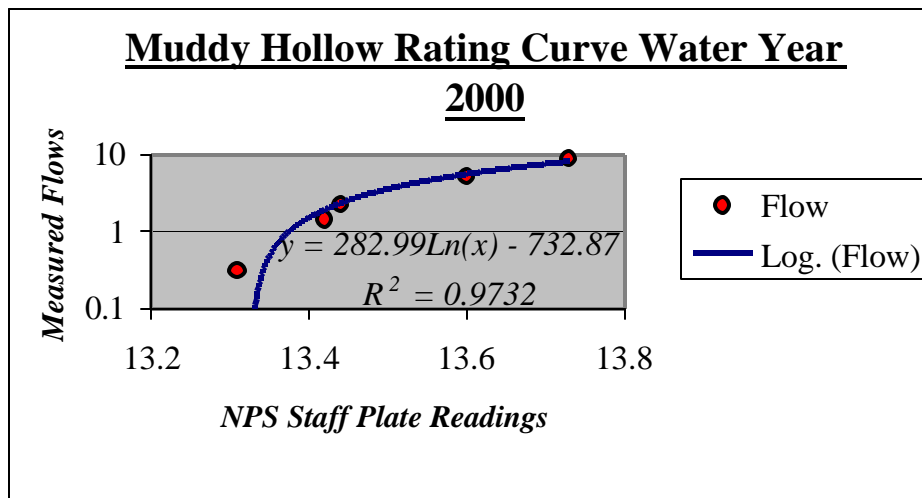
Chart 1 – Rating Curve Water Year 2000

From these data, a rating curve for Muddy Hollow has been developed so NPS staff can interpolate flow conditions during the course of the water year (Chart 1). Rating curves will be developed on an annual basis and be submitted with subsequent reports. Water levels recorded by a Global WaterLogger WL-14 are entered into the logarithmic equation to determine correlated flow conditions at the project site. The Global WaterLogger WL-14 has recorded stream water levels since its installation in December 2000 and will operate indefinitely.

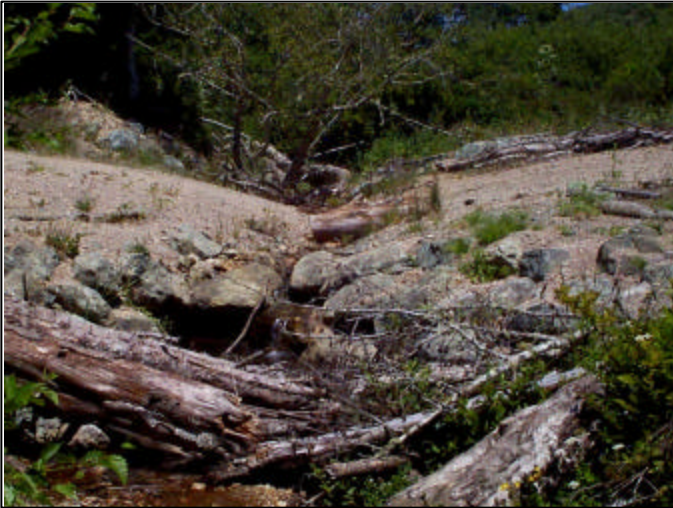
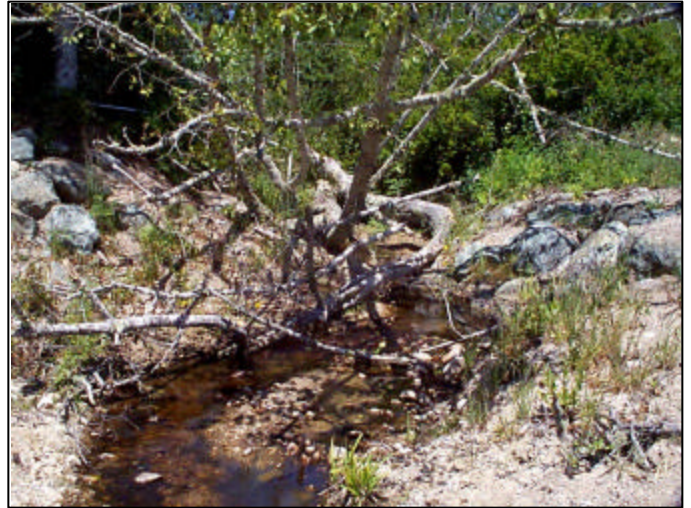
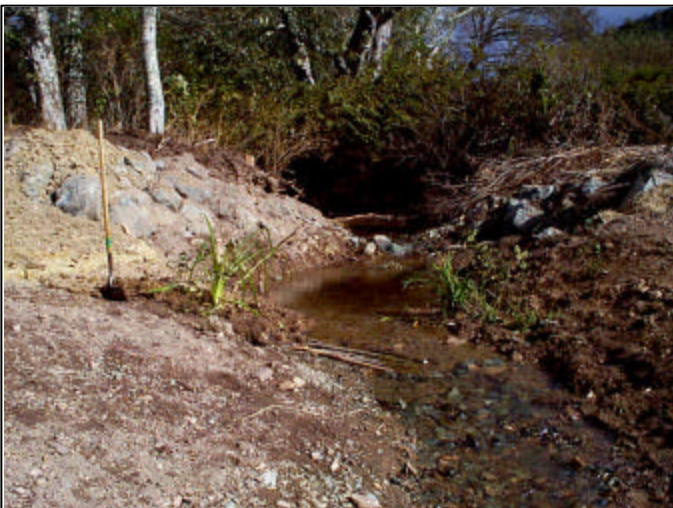
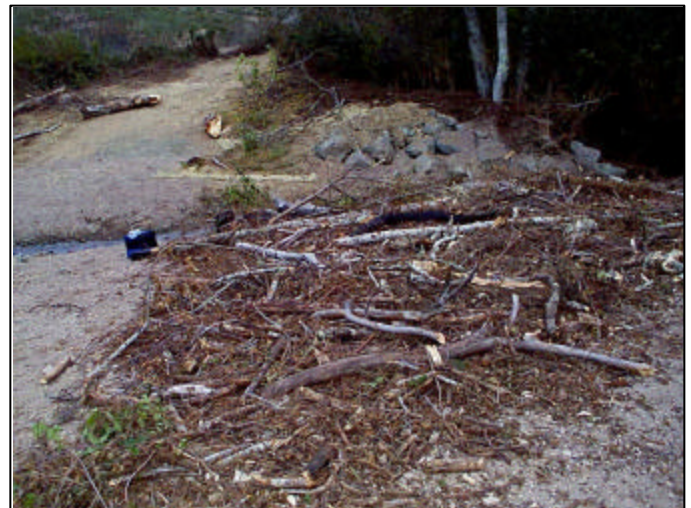
LOW FLOW AND REVEGETATION EFFORTS

No Rain fall since 03/05/01

Flow: a.) estimated at 0.15 (06/20/01) cubic feet / second

b.) 0.60 (04/19/01) cubic feet / second
