**STREAM SURVEY**

Date: April 1 and 7, 1977

NAME: WILSON CREEK COUNTY: Sonoma

STREAM SECTION: Entire FROM: Mouth TO: Headwaters LENGTH: 1.43 miles

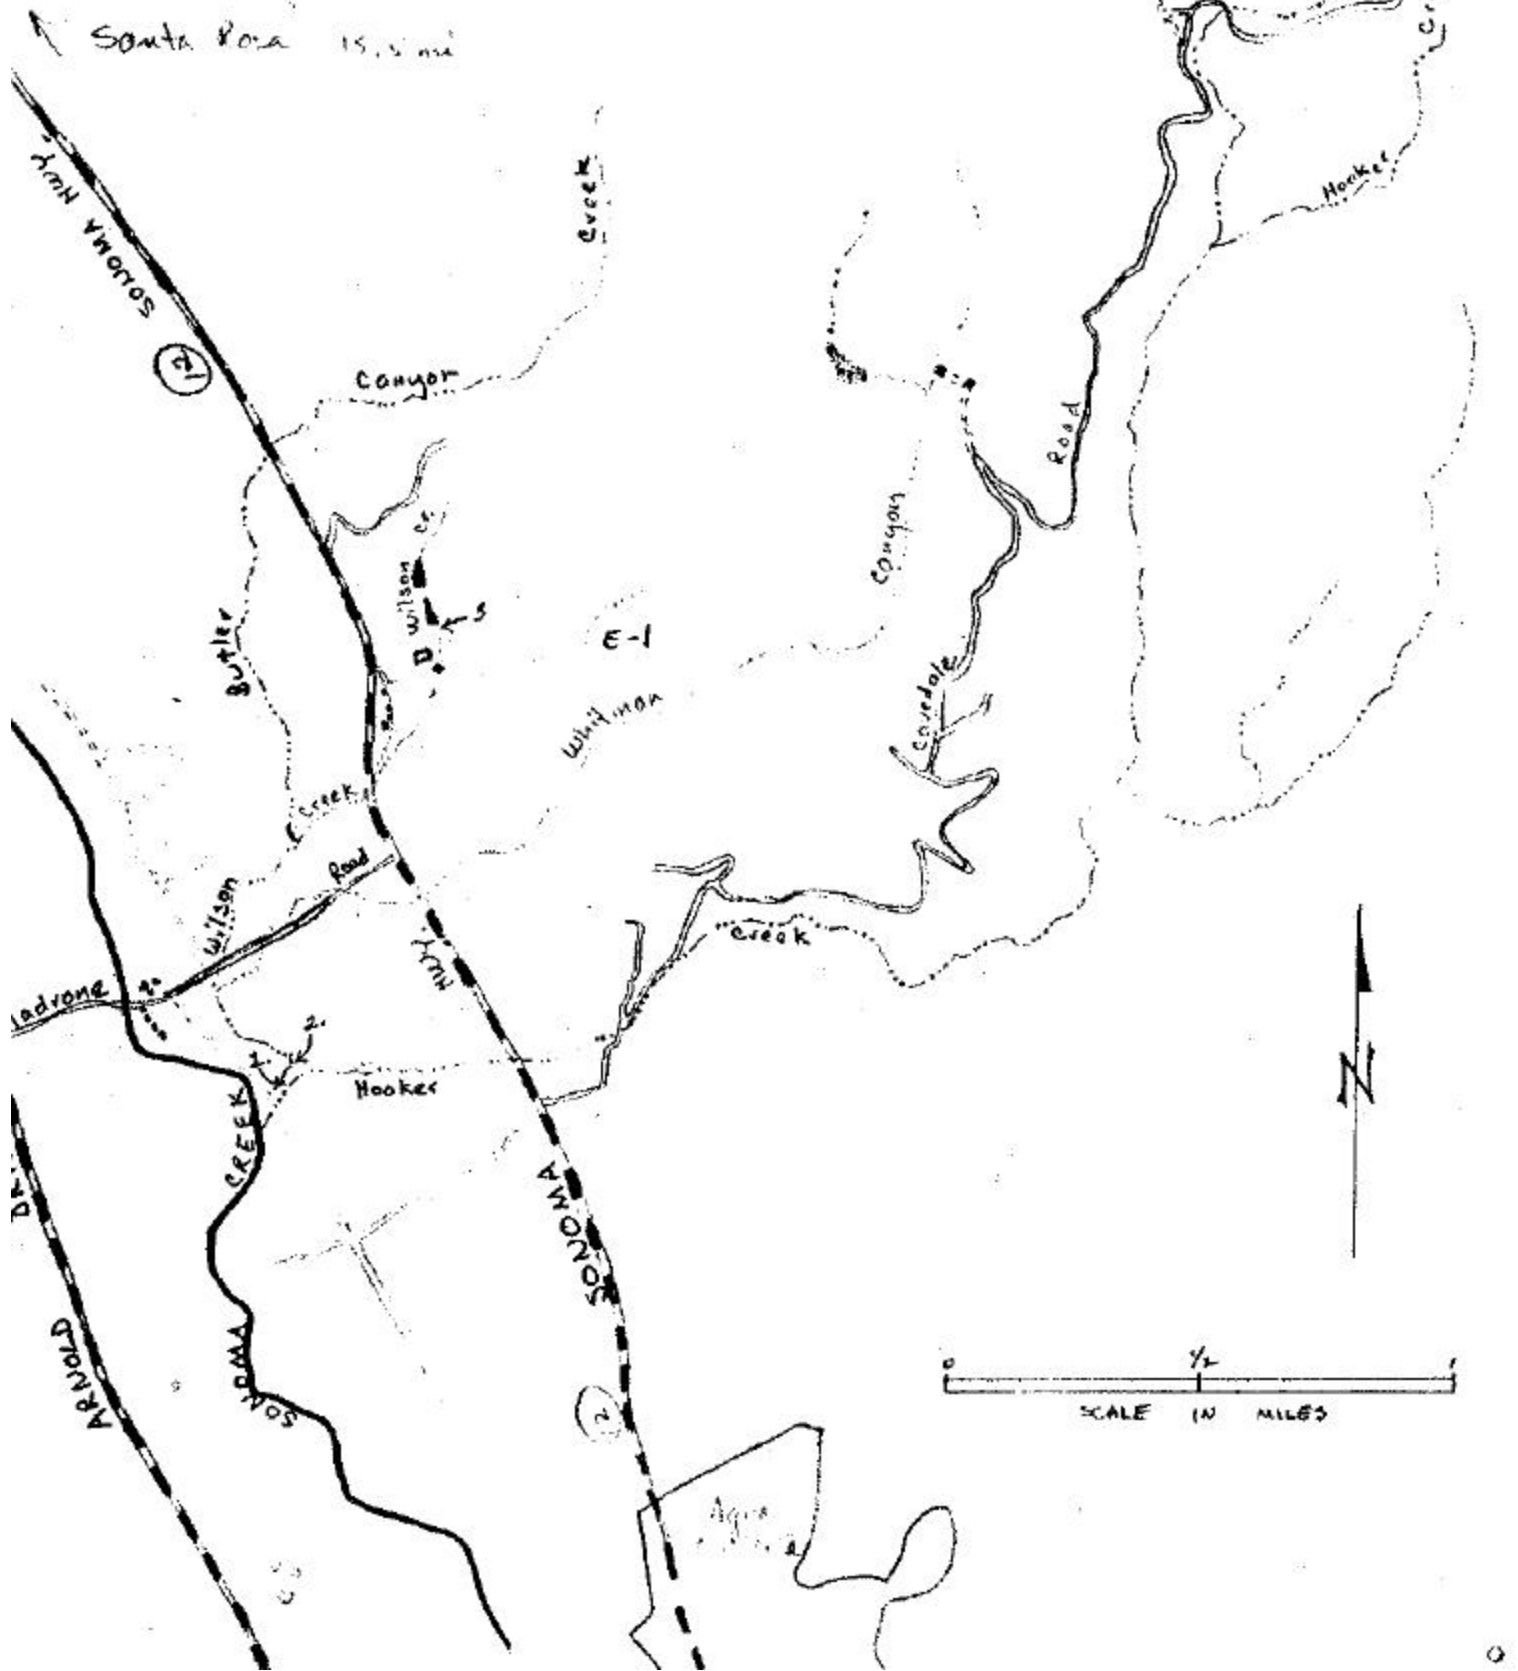
# Wilson Creek, Sonoma County

Immediate Drainage Basin - Wilson Creek drains approximately 1.2 square miles and is 1.43 miles long. There are 6.3 miles of tributaries which include Whitman and Butler Creeks and a small unnamed ephemeral tributary near the headwaters (E-1 on sketch map). The channel is V-shaped near the mouth with 20-foot banks. Near the headwaters it is relatively flat to U-shaped. The origin of Wilson Creek was obscured by plowing.

Flow - See attached sketch map for stations. Station 1 : 0.1 cfs

(near the mouth). Station 3 : 0.09 cfs (in the headwater).

Temperatures - (See attached sketch map for stations.) Station 1; water temperature 58 F, air temperature 68 F at 1130 hours; Station 2; water 50 F, air 67 F at 1100 hours; Station 3; water 58 F, air 68 F at 1500 hours.
