# California Department of Fish and Game 2002 DRAFT RUSSIAN RIVER BASIN FISHERIES RESTORATION PLAN

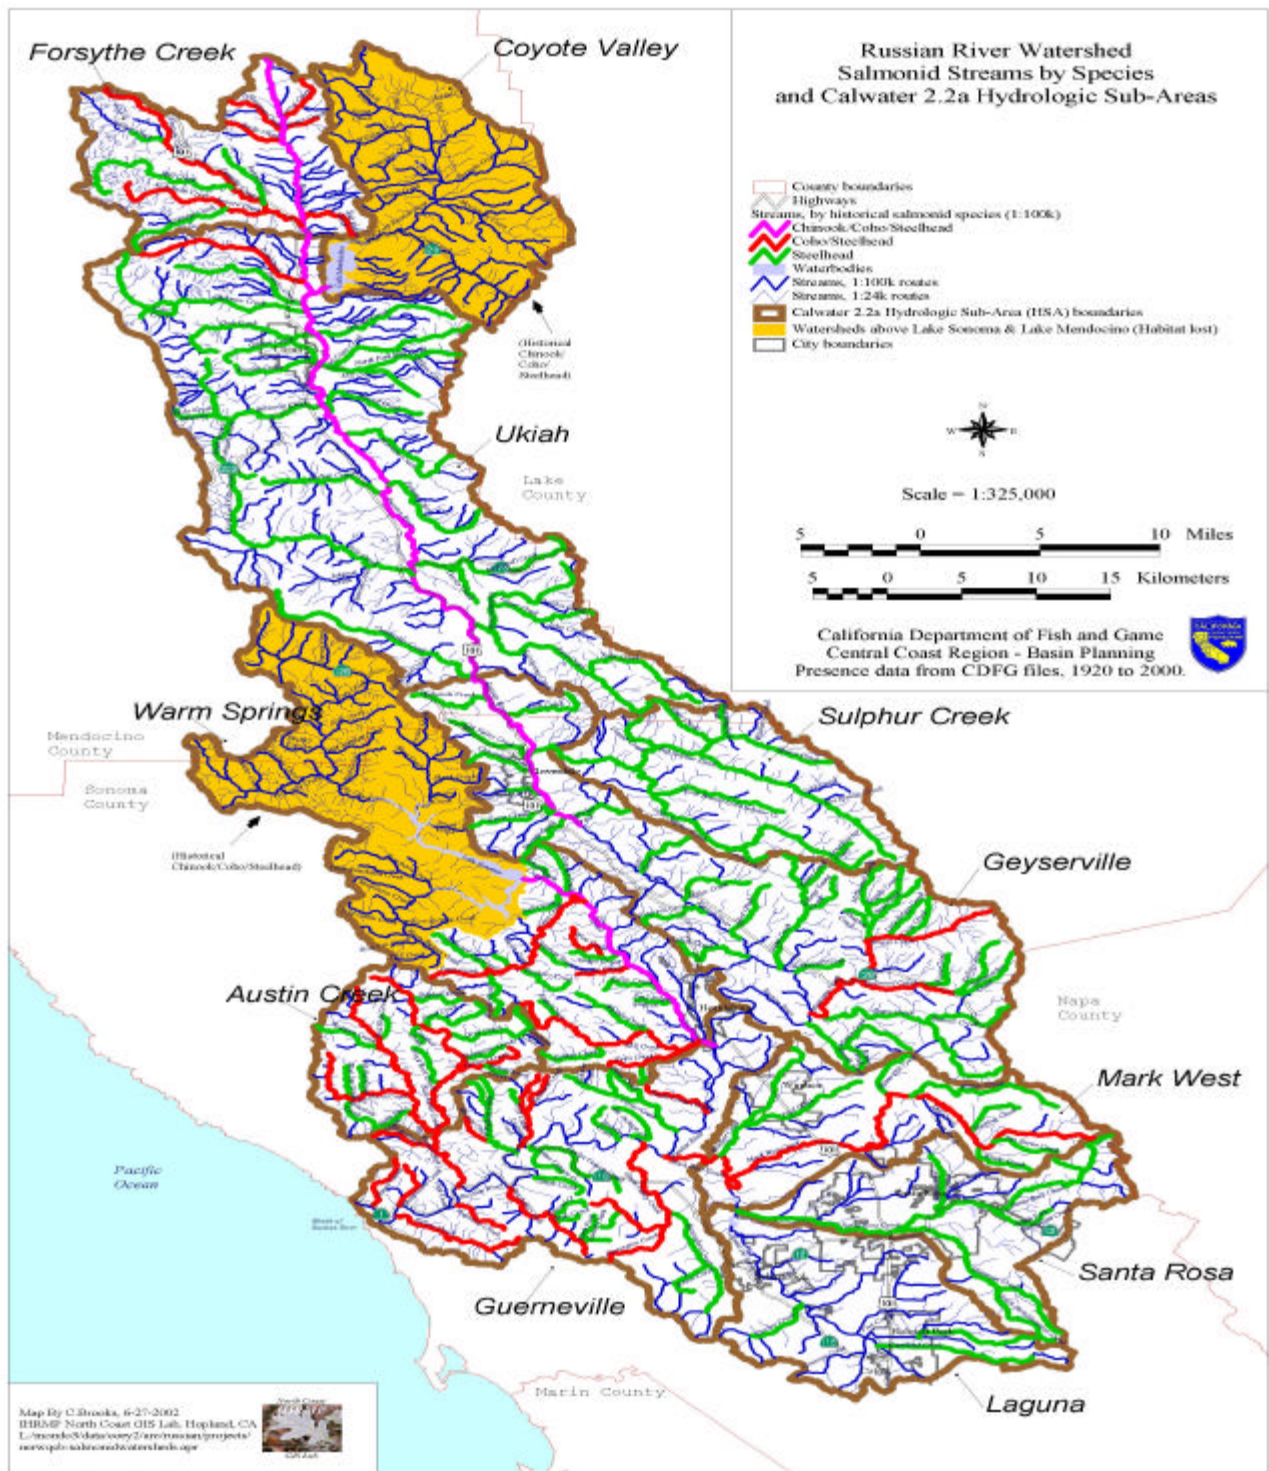
Figure 6. Salmonid distribution in the Russian River watershed (presence data from DFG files 1920 to 2002).

Steelhead utilize virtually every perennial and intermittent stream within the basin, and their distribution has not much changed, except where permanent barriers impede their migration (Figure 6). They have adapted to both the coniferous and hardwood-based systems, and even above barriers (both natural and man-made), “resident” steelhead or “rainbow trout” is found. Local human residents in the lower basin call these resident fish “mountain trout” due to the steep gradient in which they are found and the obstacles they have surmounted.

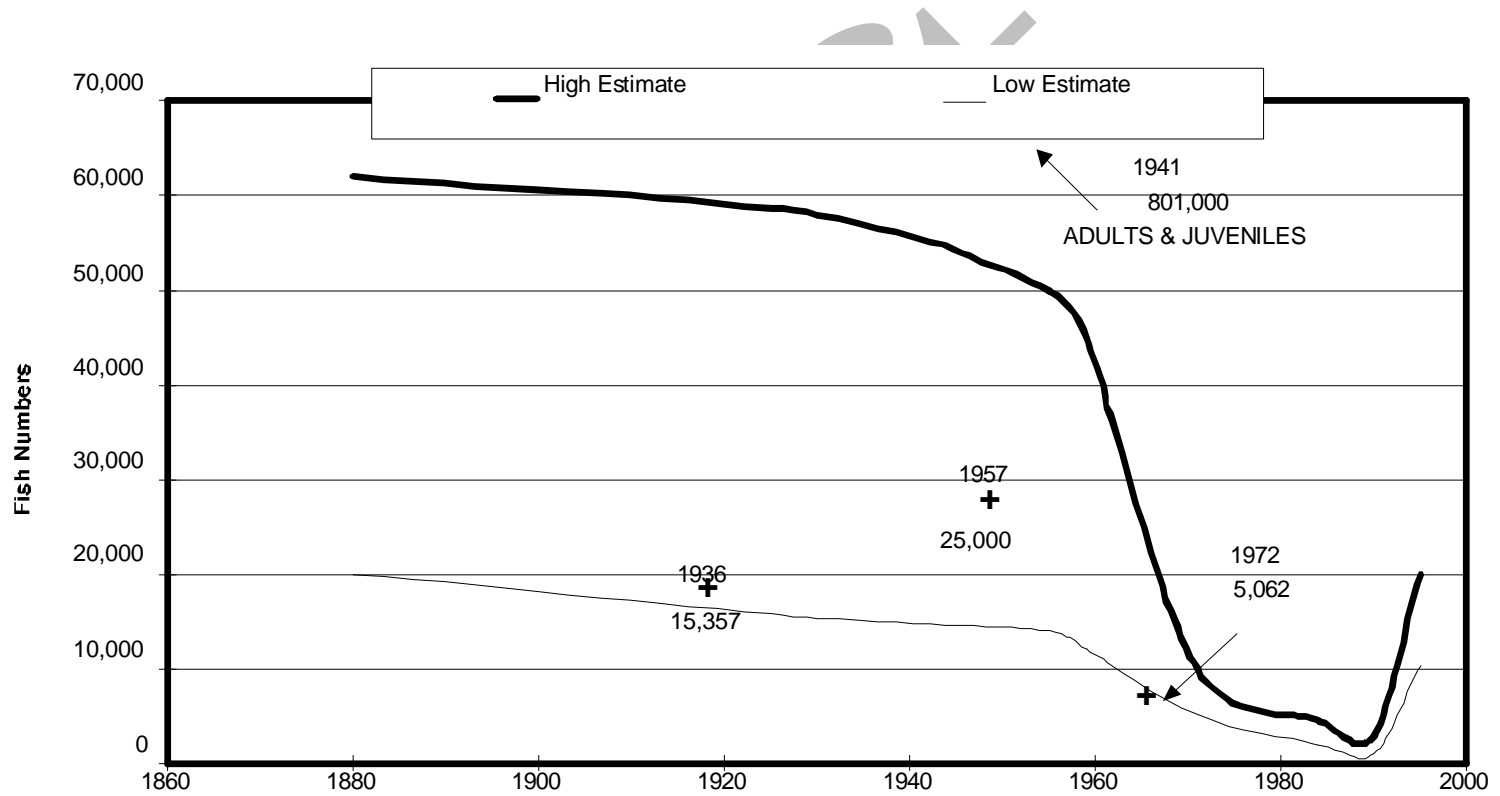
Figure 10 Hypothetical steelhead escapements to the Russian River. [Based on data from Coyote Valley Fish Facility, Warm Springs Hatchery, and estimates from CDFG personnel. All data points marked + from Prolysts (1984).]

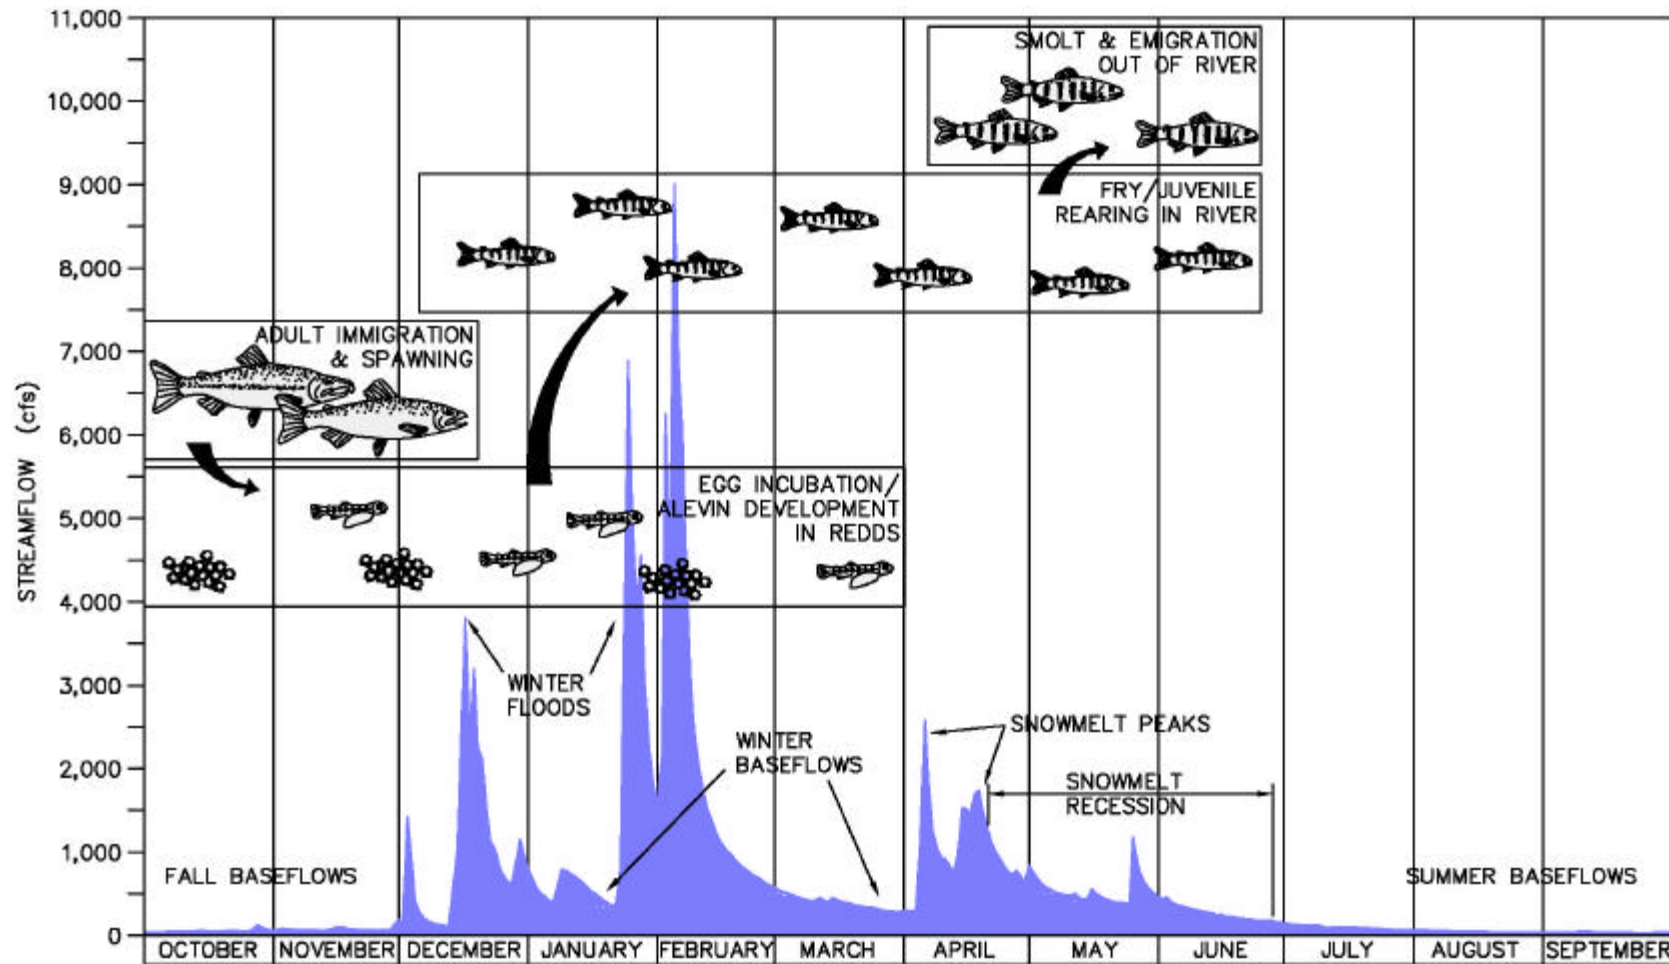
Figure 13 – Hypothetical correlation of salmonid life cycle to flows. Courtesy of The Lower Clear Creek Technical Workgroup (Bureau of Reclamation, 1999).
