THE RESOURCES AGENCY OF CALIFORNIA
DEPARTMENT OF FISH AND GAME

STREAM SURVEY

NAME: JENNER GULCH CREEK COUNTY: Sonoma

STREAM SECTION: complete FROM: Mouth TO: Headwaters LENGTH: 2½ mi.

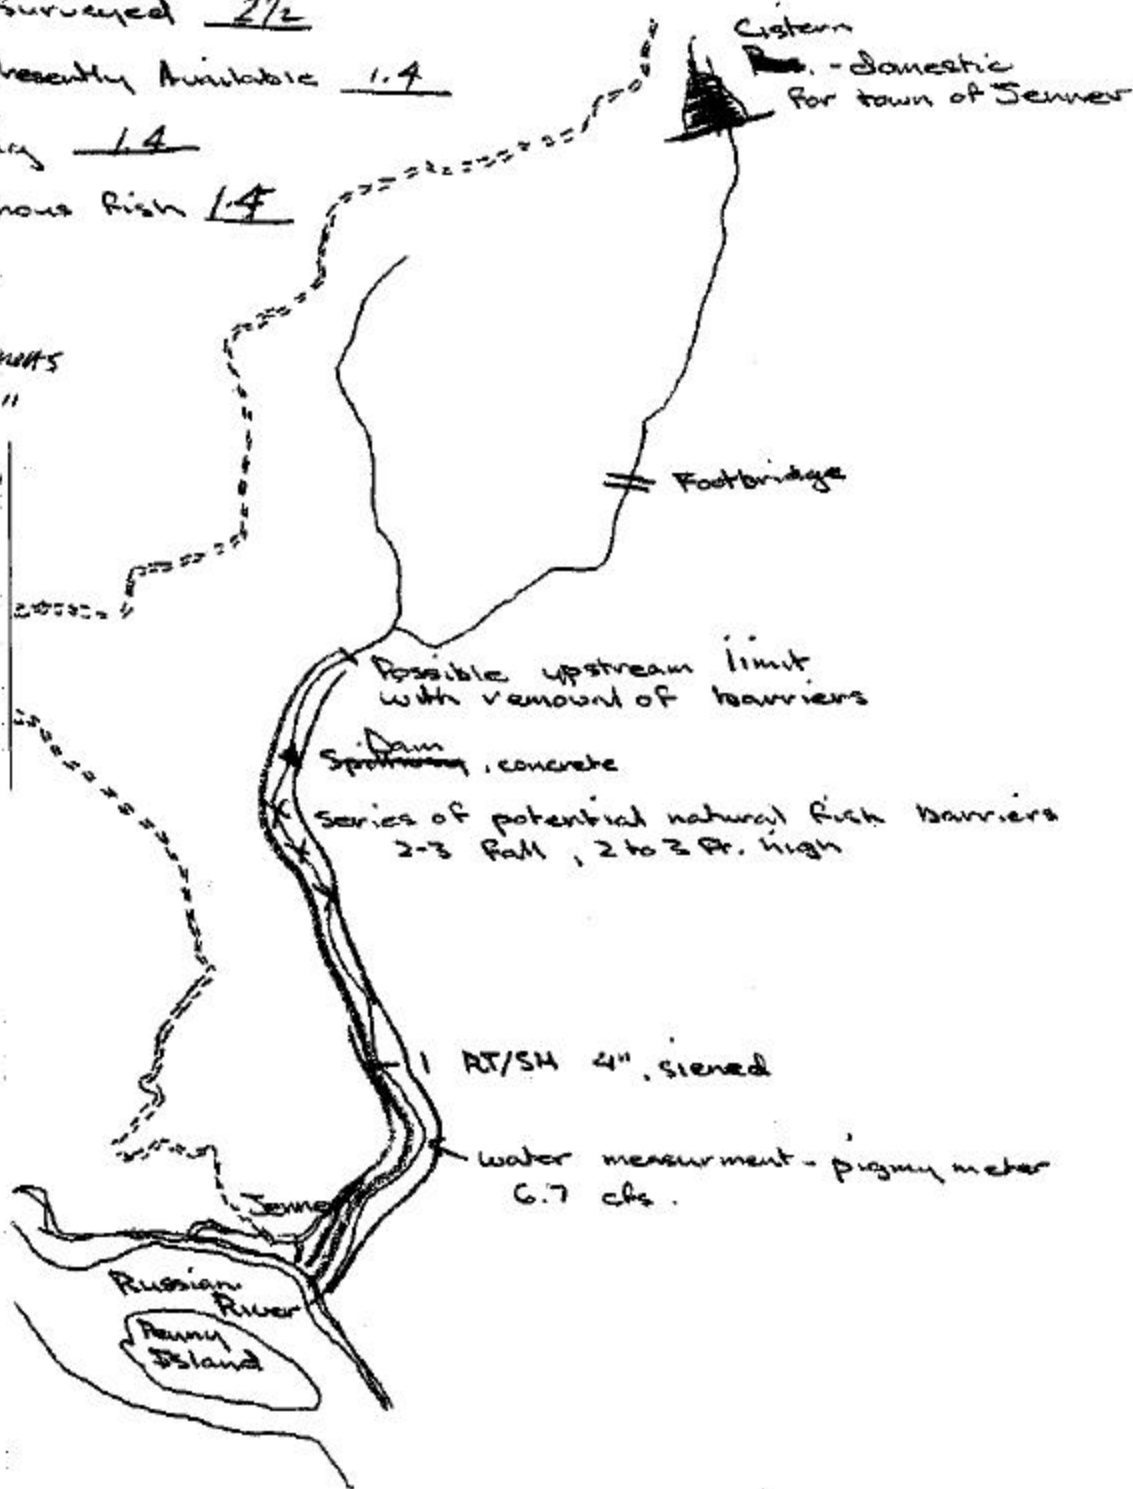
Jenner Creek or

Spawning Areas - There are very few spawning areas and those present are relatively poor. The gravel is either too large, or small and silted in. See map for best areas.

Barriers - One presumably complete log jam barrier was found in the upper-middle section of the stream. Also, there were 3-4 partial log jam barriers, one small concrete dam (2 feet high), and many complete and partial boulder barriers. These boulder barriers, however, were primarily in the uninhabitable headwaters (uninhabitable because of steep gradient).

Important Statistics

Miles of Stream Surveyed 2 1/2

Miles of Stream Presently Available 1.4

to spawning 1.4

to anadromous fish 1.4

RECOMMENDED MANAGEMENT - Removal of some of the major log jams and rock barriers would make more of the stream available to anadromous fish and might improve the spawning areas. Continue to manage the stream primarily as a spawning and nursery area for SH/RT. Silver salmon might be reintroduced. Also that this stream be considered important "escape habitat" for downstream migrants during flood conditions.
